CASE STUDY | Bending Tests of Repaired Marine Timber Piles

Bending Tests of Repaired Marine Timber Piles

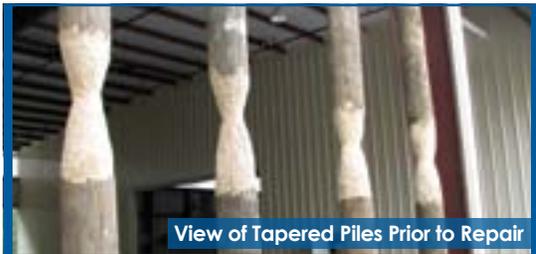
View of Tapered Piles Prior to Repair

Six timber piles were used in the test program as summarized in Table 1. All piles were 16' long, approximately 8" in diameter, and of treated southern pine. To simulate marine damage, five of the piles had an hourglass-shaped taper cut into them at mid-span (four of the tapered piles are shown above prior to

repair). One pile (Pile #0) was used as the line base specimen and was undamaged.

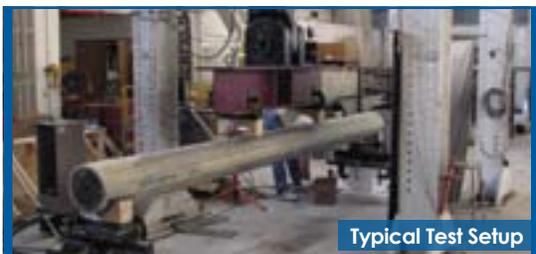
Typical Test Setup

The six pile specimens were tested in bending using a four-point bending setup (simply supported with two equal loads equally spaced from the mid-span). Rocker bearings were used at the supports to allow rotation of the ends of the specimens during loading. The span length for each pile specimen was 15 ft., measured from center to center of the support

bearings.

A single 220,000 lbs. capacity actuator was used to apply the load. While the capacity of this actuator exceeded the expected max bending capacity of the pile specimens, it provided a max stroke of 30 in. The actuator was operated with a MTS FlexSystem-60 controller. The actuator was operated under load-control with a constant load rate of 250 lbs. per second. A spreader beam was used to evenly apply the load to the specimens, four feet apart. Wooden support saddles, made up three 2 x 8 dimension lumber, were used at the supports and the load points. This gave a bearing length of 4½ in. The saddles had cut-outs that matched the radii of the pile specimens. Neoprene pads, ¼ in. thick, were used between the saddles and pile specimens

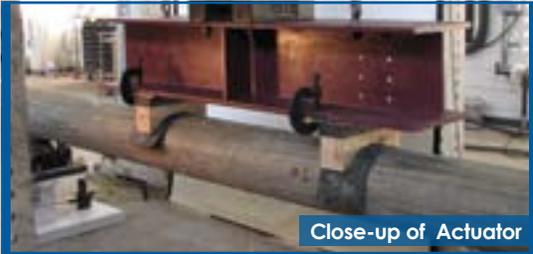
Close-up of Actuator

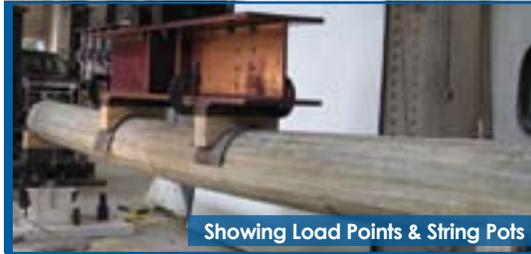
Showing Load Points & String Pots

The displacement of the actuator was measured using the actuator's built-in linear voltage displacement transducer (LVDT). However, this over-estimated the mid-span deflection of the specimens due to the flexibility at the supports and the load points. Therefore, linear string pots, located at the end supports and

at mid-span, were used to provide a more accurate measure of the mid-span deflection. The average of the end deflections was subtracted from the mid-span deflection, as measured by the string pots.

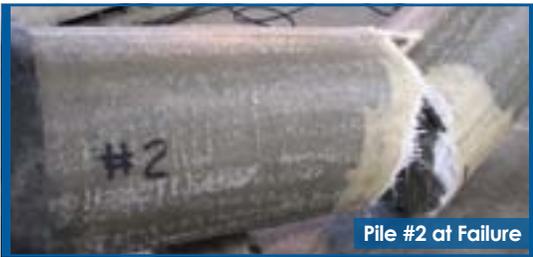
Pile #2 at Failure

The results of the six pile bending tests are summarized in Graph 1 & 2. In general, all repaired piles exceeded the bending strength of the baseline pile (Pile #0) by at least double the maximum load achieved by the baseline pile (9,050 pounds). Above left image provides a view of Pipe #2 at failure.

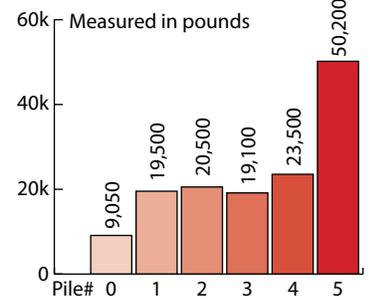
GRAPH 1

BENDING TEST RESULTS

Maximum Load

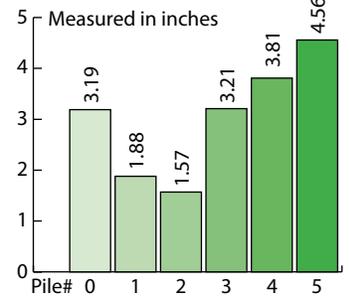
GRAPH 2

Mid-Span Deflection at Max Load

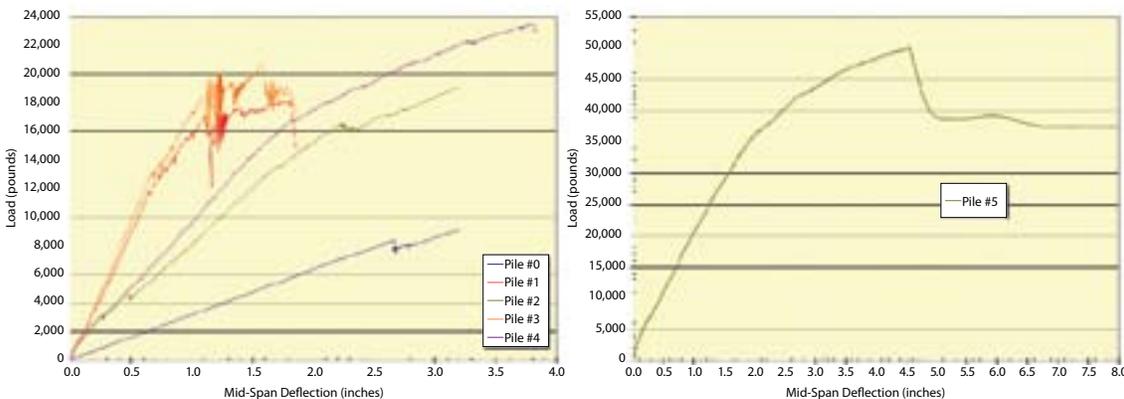
PLOT OF LOAD VERSUS DEFLECTION
