PROTECTIVE COATING ON STEEL WATER MAIN

PROJECT DATA

Location	Port Kembla (NSW)
Contractor	RMP Abrasive Blasting
Client	Sydney Water
Products	Denso Petrolatum System
Date	2017
Ref No	E016

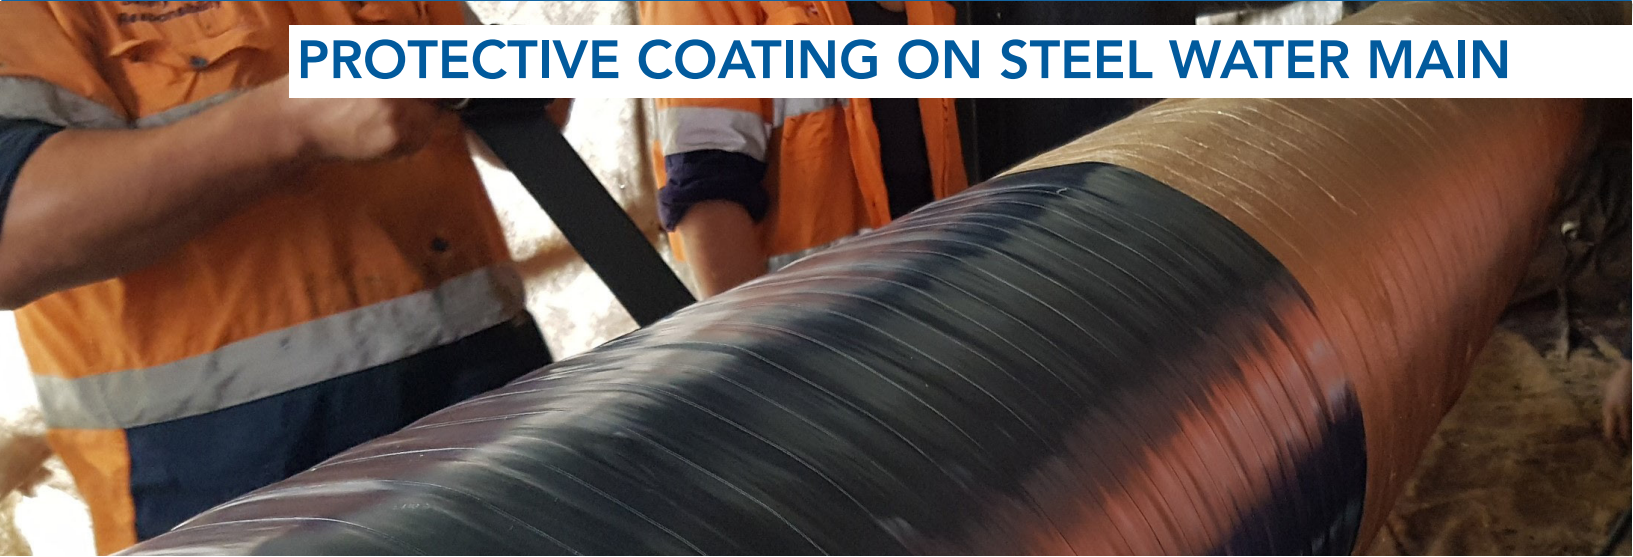
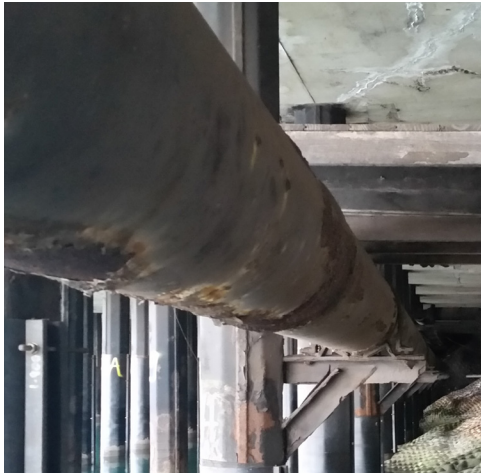
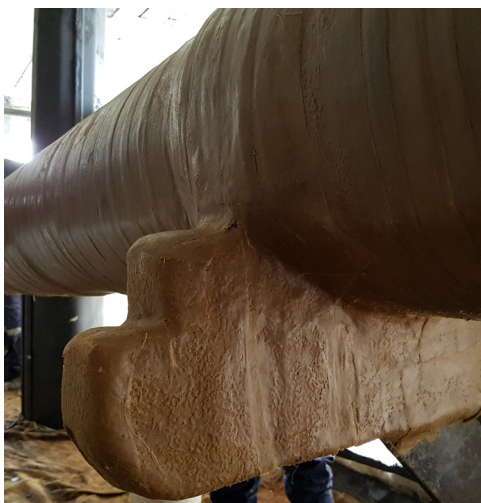
Before and after application of the Denso Petrolatum Tape System.

The 375mm DIA water main and brackets were initially high pressure water blasted with the inclusion of Holdtight® 102 to remove salt contamination, and then mechanically cleaned prior to the application of Denso petrolatum primer, Denso profiling mastic and spirally wrapped Denso petrolatum tape.

An outerwrap of Denso PVC SA tape was also spirally applied to provide the underlying components' mechanical protection.
