Volume 30 - Number 4

SeaShield 2000FD system used to protect 3 huge mono piles in the Golar FSRU Khannur (West Java) Project, Indonesia - see pages 8 and 9.

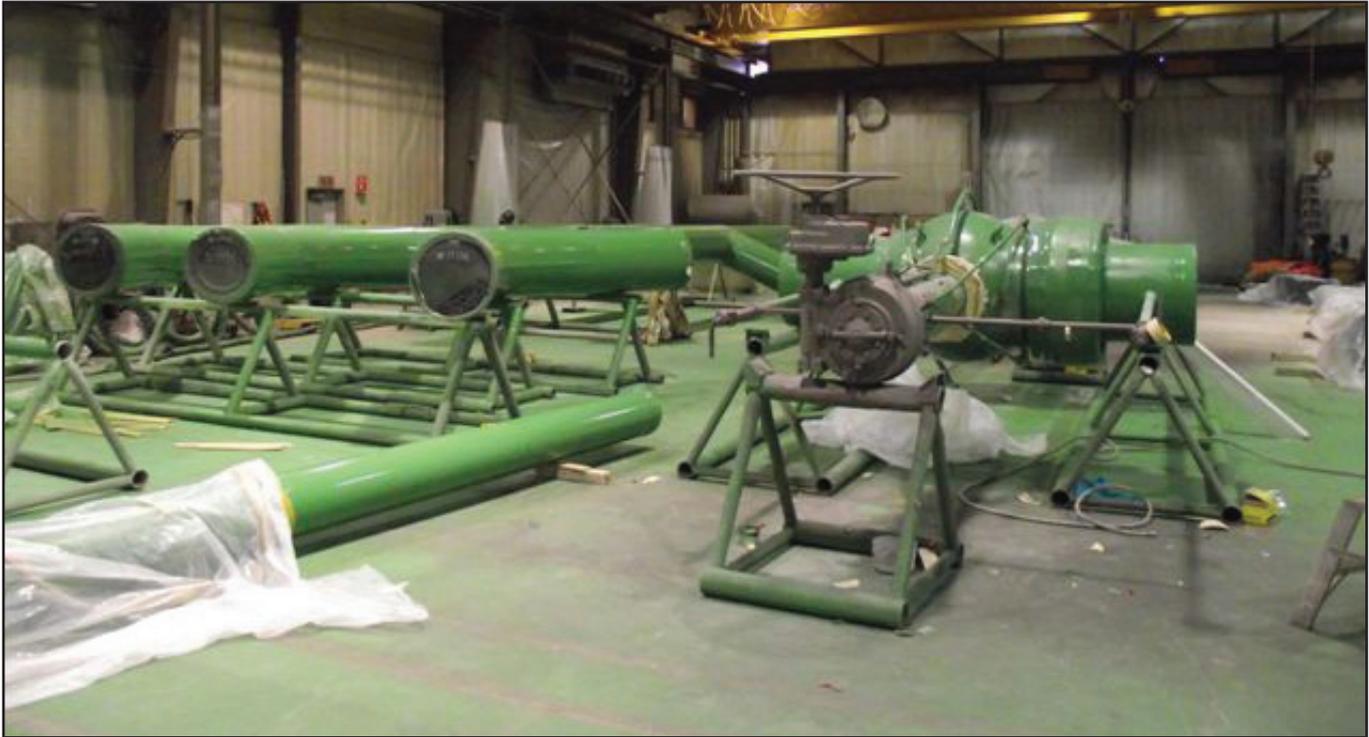
Factory coating pipelengths with Protal Liquid Epoxy.

continues to develop over time starting off from a strictly mechanical metering and pumping unit which limited the ratios that could be used, i.e. 3 to 1, to modern day electronic metering pumps that can spray out 100 to 1 ratios. The setup costs of a good pump system these days including hose bundles, spray whips, heaters, etc. can easily run into the hundreds of thousands of dollars. A commonly used Plural Pump System used in Canada is the Graco Xtreme Mix Plural Component Series and is an industry workhorse.

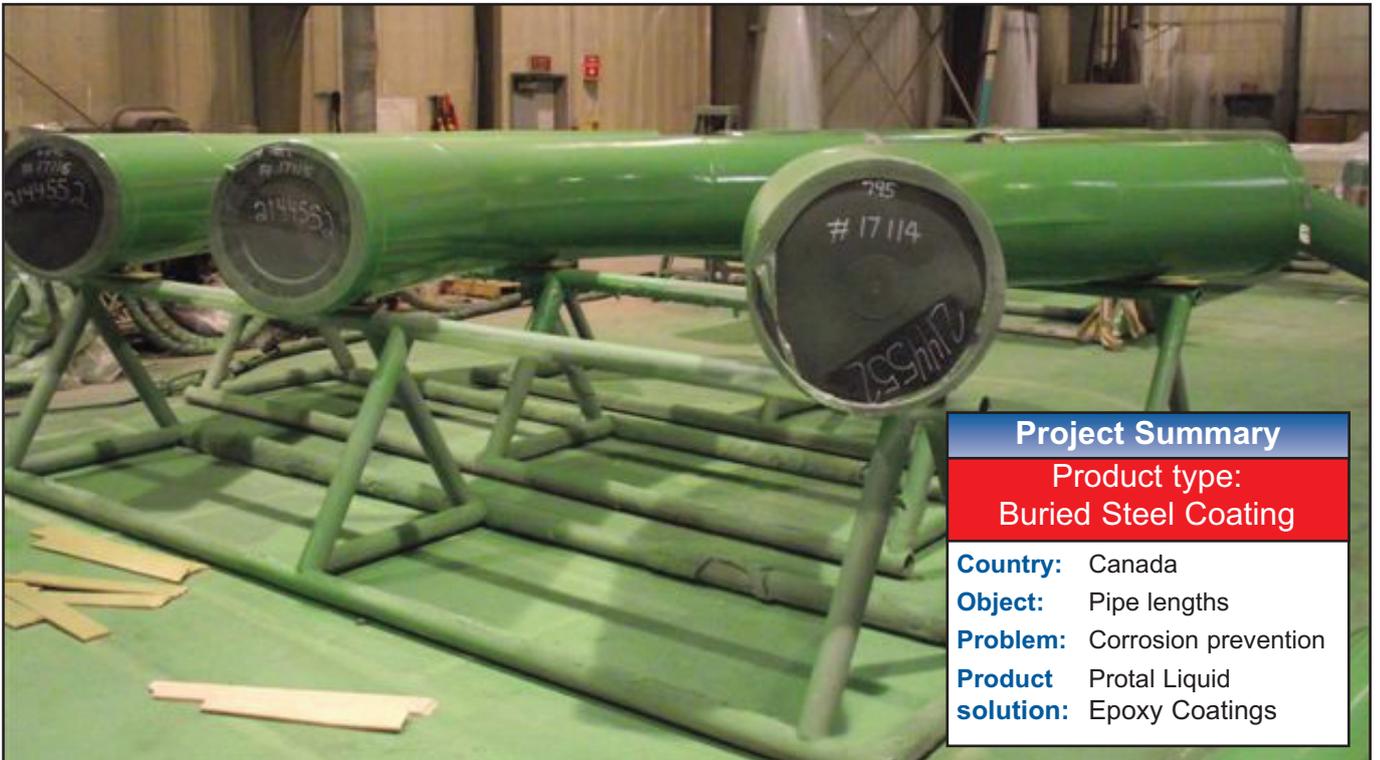
Protal Liquid Epoxy coated pipelengths ready for transportation.

It is not uncommon to be traveling down any freeway in Canada and see a load of pipe coated with Denso Protal 7250 being transported from a coating facility to the field where it will be used in oil or gas production, transportation infrastructure or in large water pipeline projects.

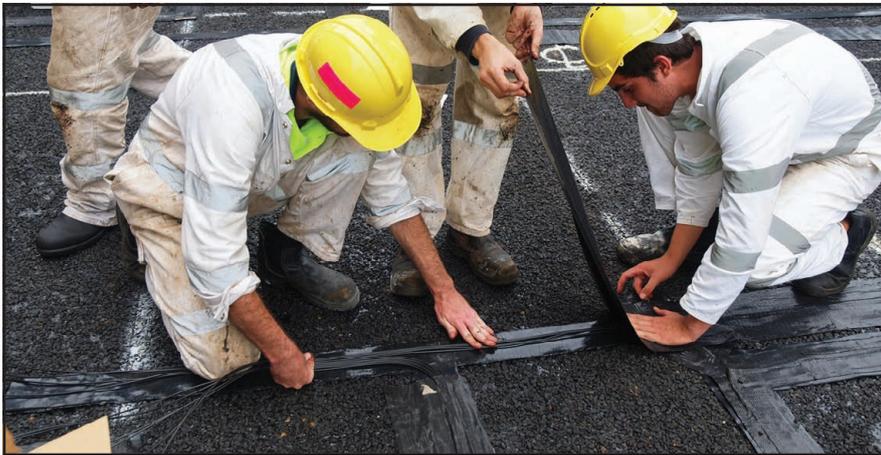
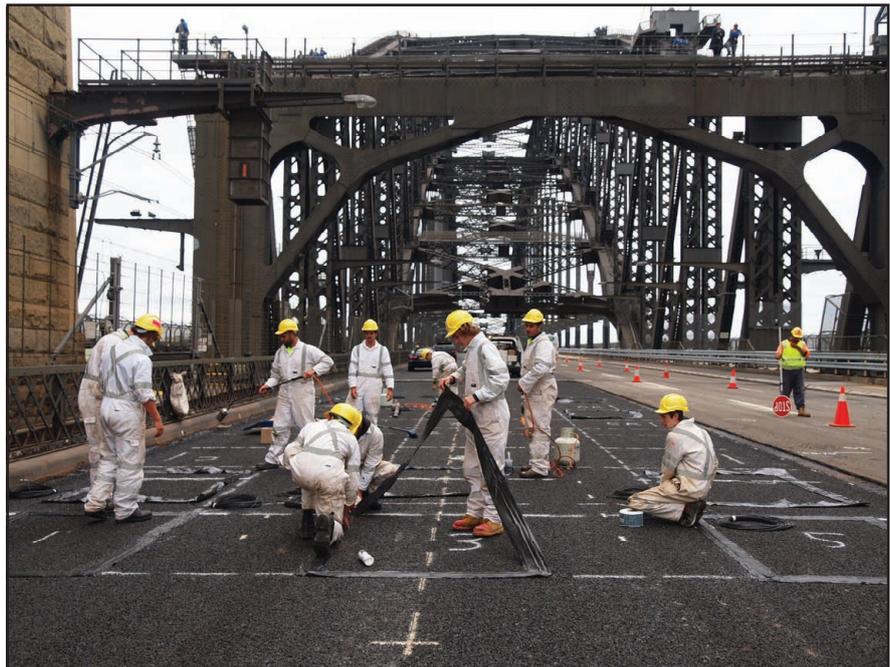
Photos above and below: Fixing the Ezyloops to the new bridge road surface.

The sub-surface Ezyloops are manufactured using TechBand (Densoseal 450) and Densopol 100, which encase the signal sensor cables which are connected to a roadside control unit. The Denso bitumen products are ideal for this type of installation as they are flexible, long lasting and can withstand hot asphalt pours.

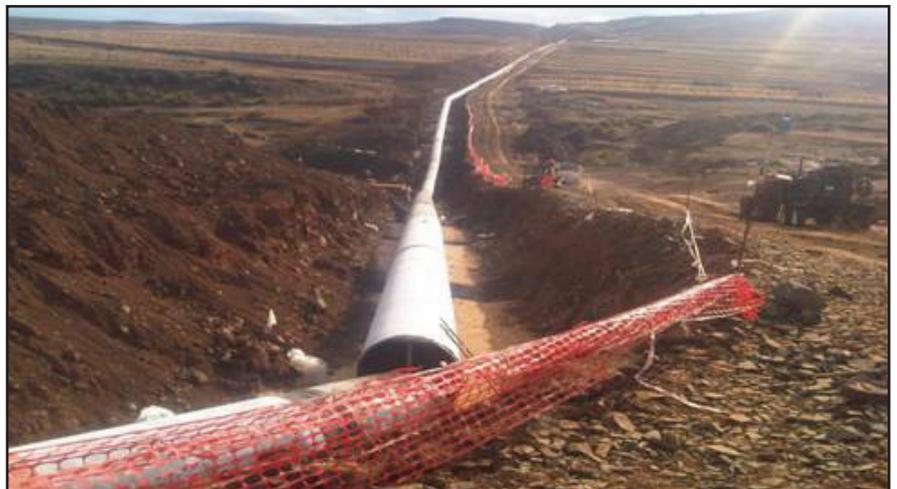
Above: The water pipeline in situ.

The Bituguard coated pipe extends from the Dam wall for approx 6km from where the smaller dia Sintakote pipe leads to the reservoirs.

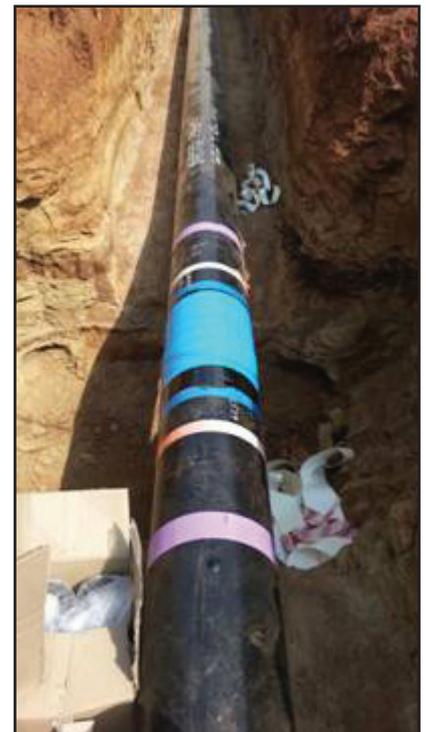
Below: The water pipeline joints protected with Denso Ultraflex 1250.

Denso Ultraflex 1250 and Weldbead Tape were recommended for the field joint repairs on the Sintakote pipe.

Project Summary	
Product type: Buried Steel Coating	
<b>Country:</b>	Lesotho
<b>Object:</b>	Water pipeline
<b>Problem:</b>	Field joint repairs
<b>Product solution:</b>	Ultraflex 1250, Densotherm HD & Stoneguard

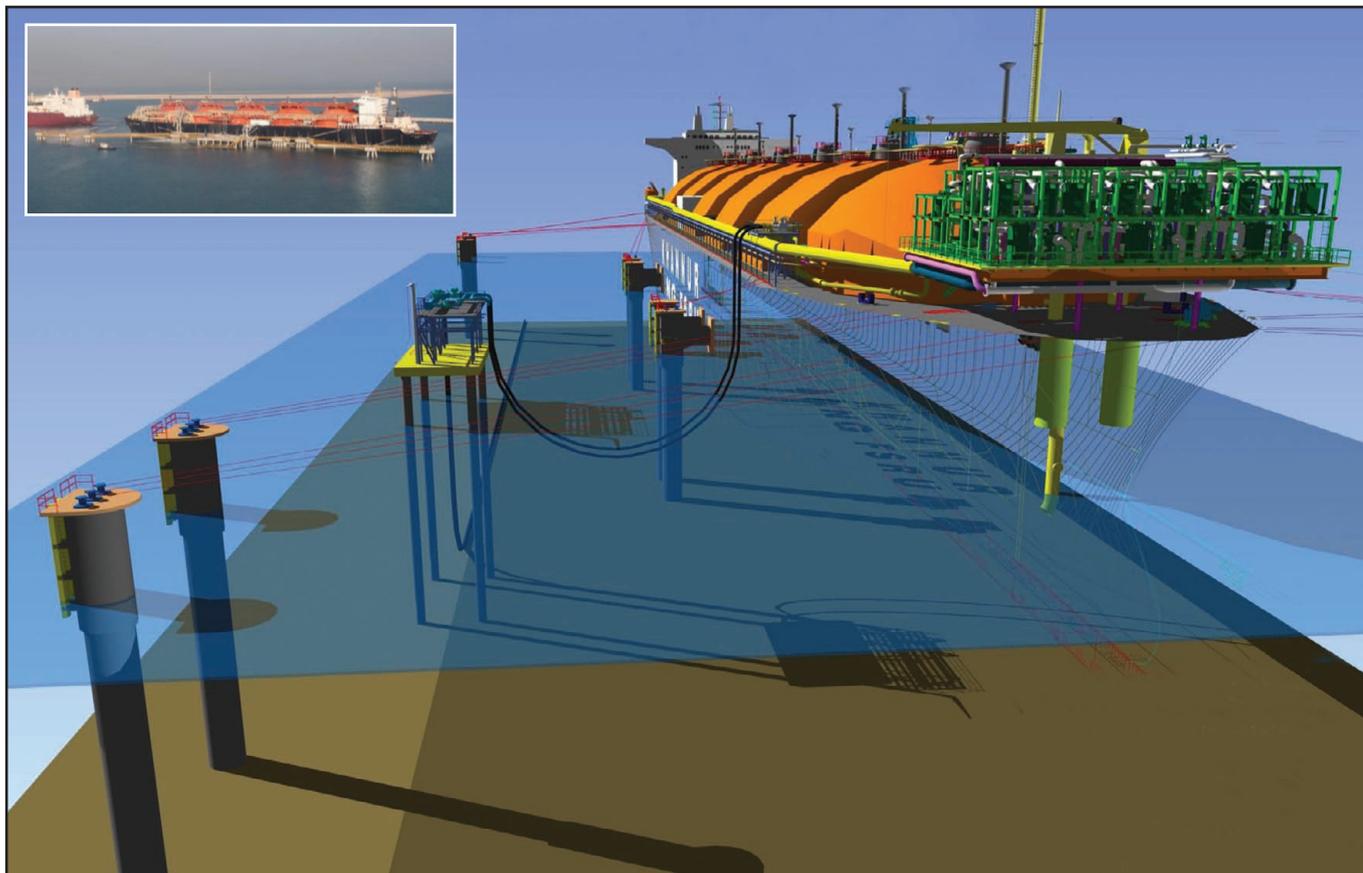
Diagram of the Floating Storage and Regasification Unit (Inset shows one of the shipping vessels used to transport gas).

At the Golar Floating Storage and Regasification Unit in the Java Sea, 15km north of Jakarta, Imbema installed a cathodic protection system to protect ten huge monopiles against corrosion for a period of 15 years.

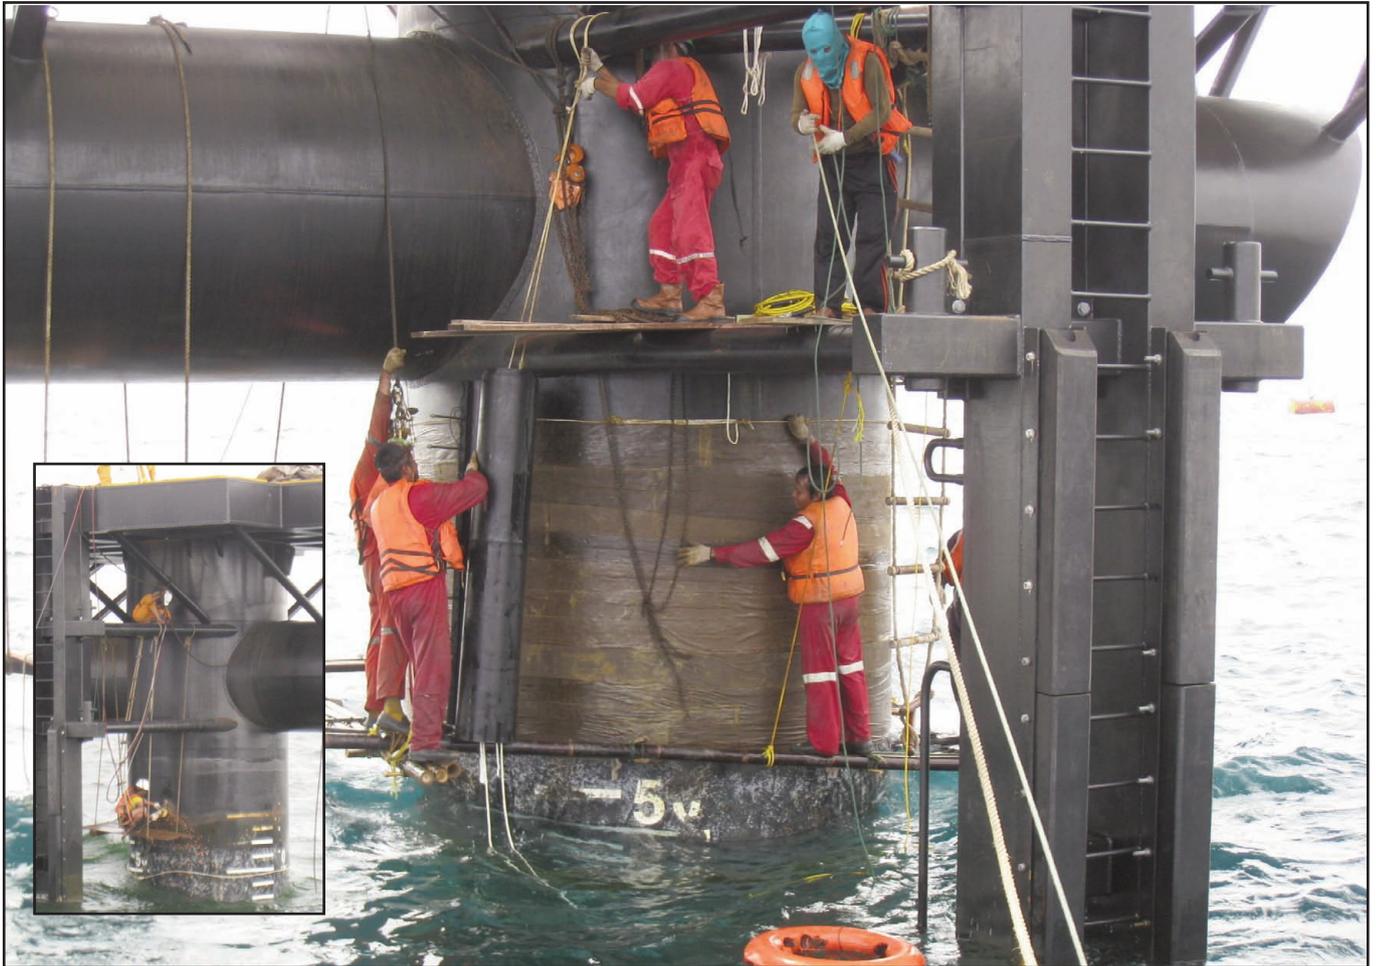
After first cleaning the designated pile area (inset) for the SeaShield system, a coating of Denso S105 Paste is followed by a double wrap Denso Marine Piling Tape.

SeaShield systems have been in use in Indonesia for over 30 years now. Denso Paste S105 and Marine Piling Tape have proven to encapsulate and protect steel surfaces, even at very high ambient temperatures. At the same time the SeaShield HDPE jacket and closing system resist the negative influences of the intensive tropical ultraviolet sunlight.

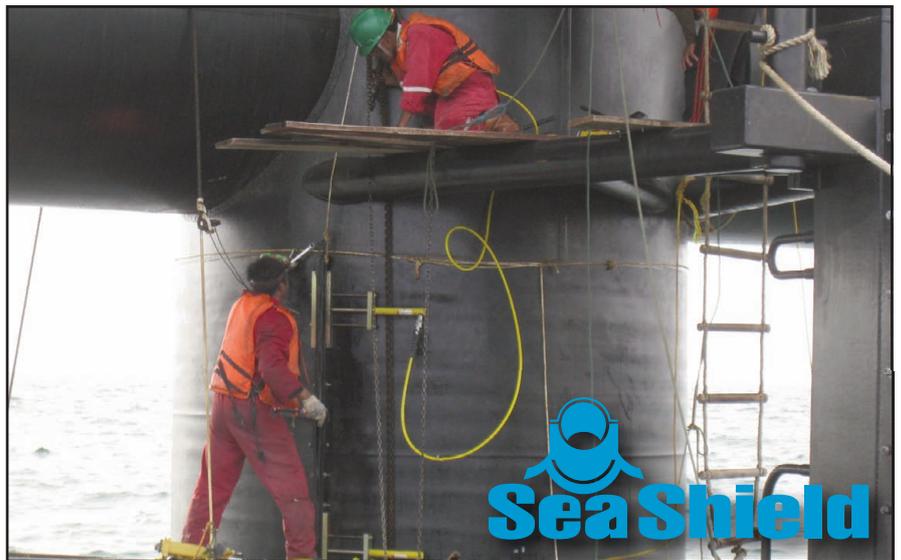
The HDPE jacket is installed, completing the SeaShield 2000FD system.

London recommended the installation of the Denso SeaShield 2000FD system. Normally the SeaShield jackets wrap around the pile and have one seam which is bolted together. In this case because the piles were so large the jackets needed to be in two halves, requiring two seams to be bolted together on each pile.

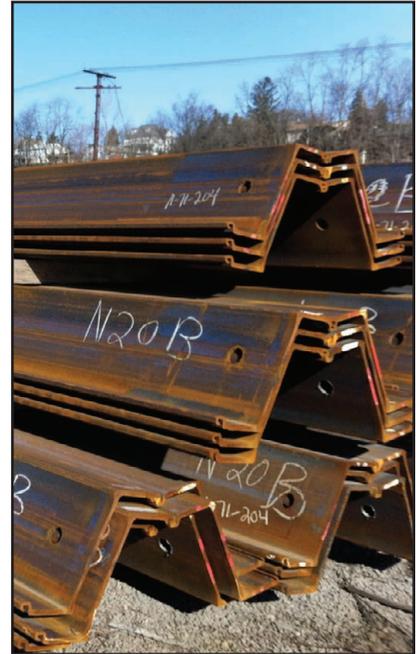
Uncoated steel sheet piles.

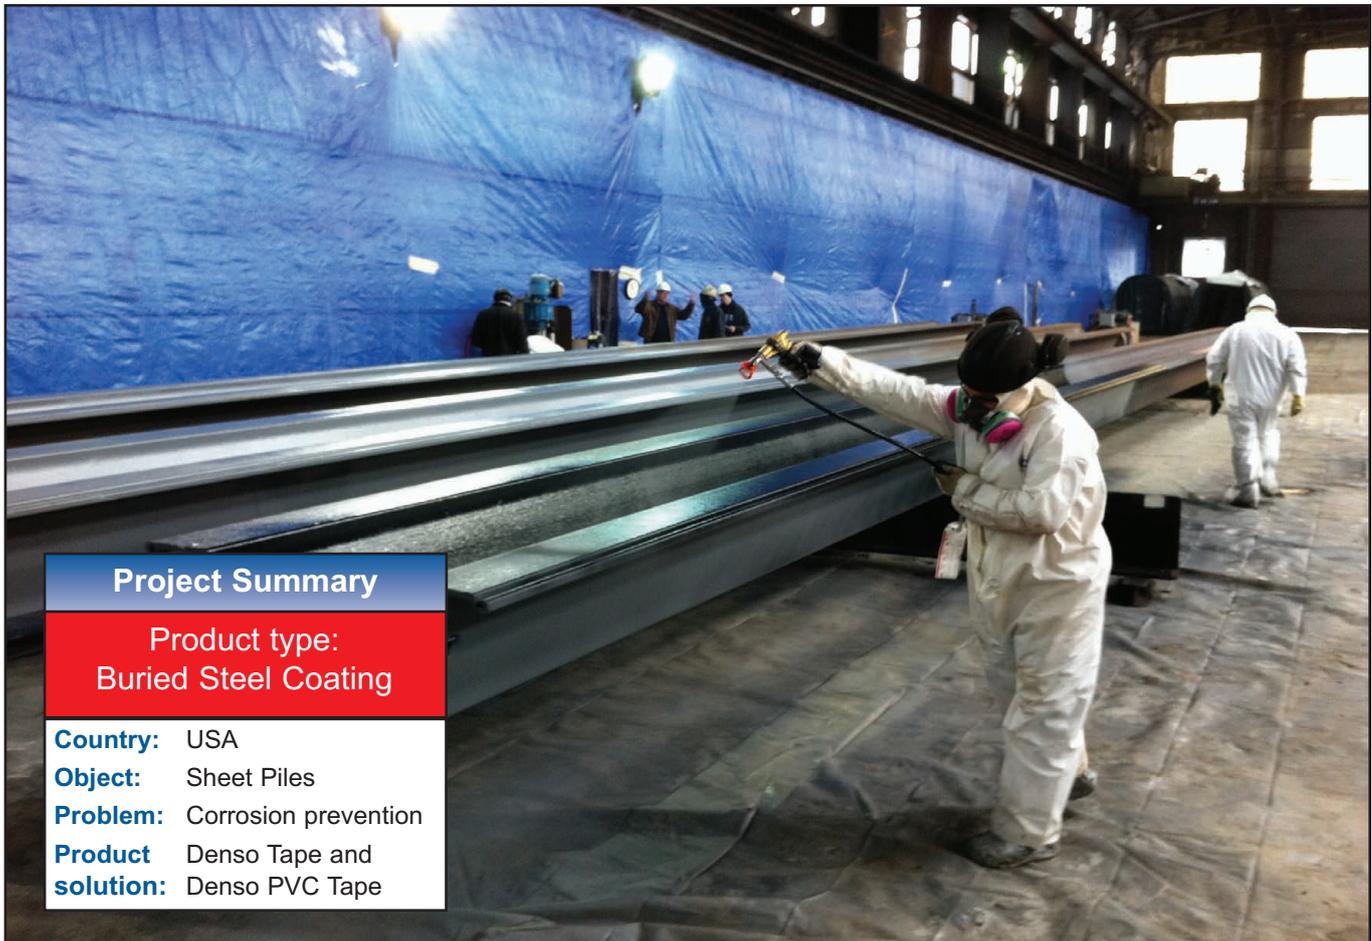
Spraying two coats of Denso Rigspray to achieve 60 mils.

structures exposed to corrosive marine environments. A dual layer coating (30 mils black and 30 mils gray) was specified to achieve 60 mils of coating protection.

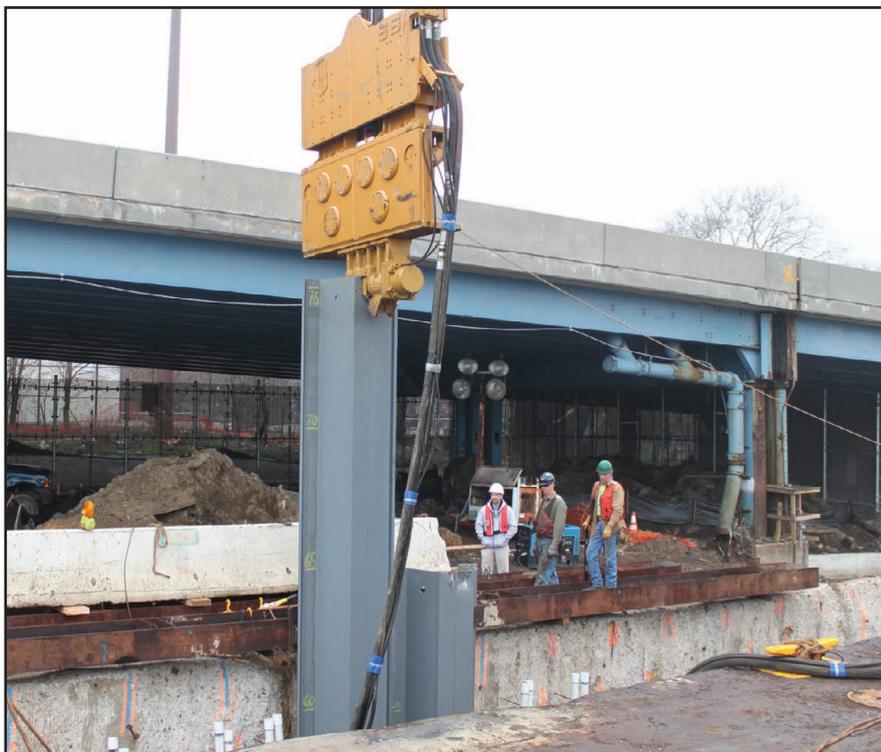
Driving the sheet piles.

Due to the sheer size and weight, 15,000 lbs (6,804 kgs) per sheet pile, a crane was first used to position the sheet piles in place before they were driven into the mud line.

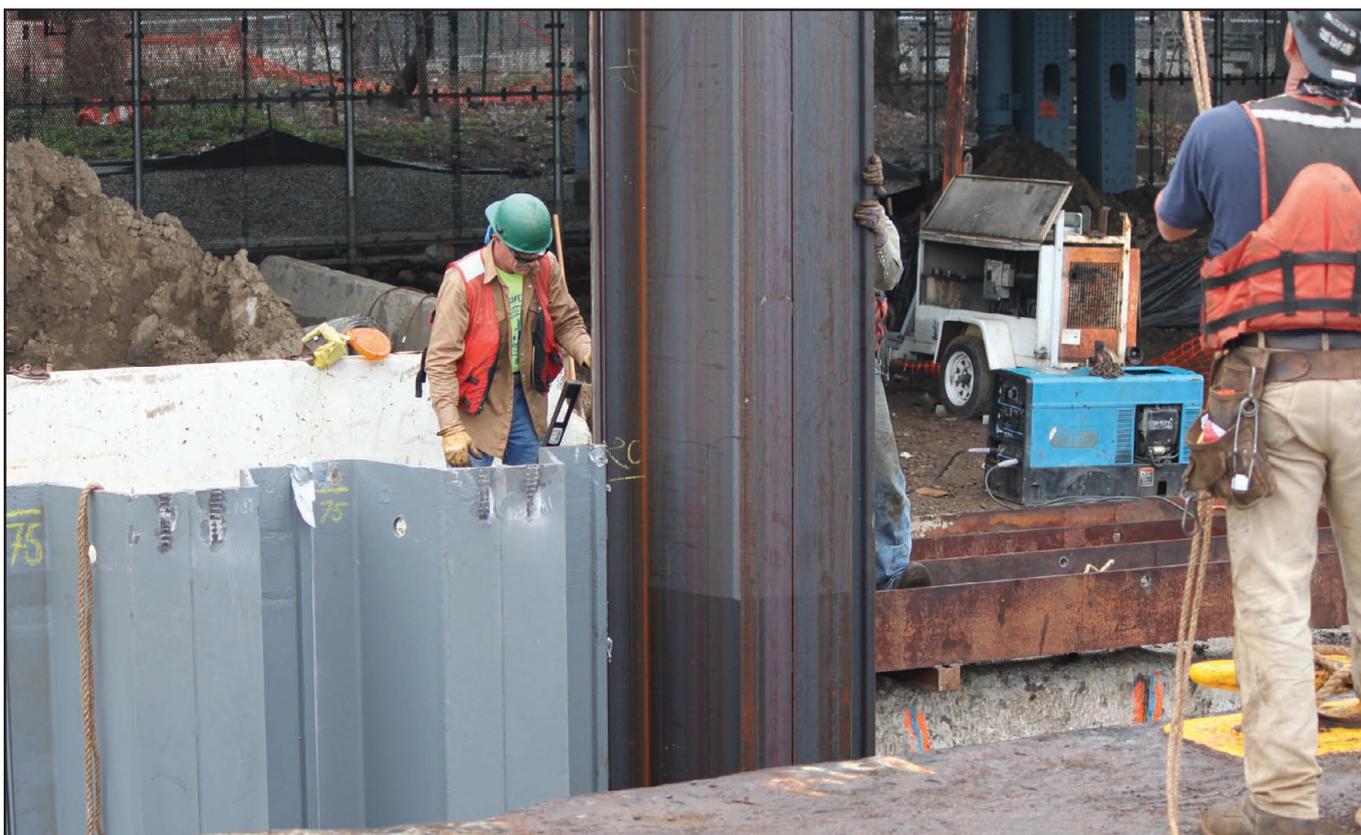
Aligning the pile as it is being driven down in place.
