# DENSO DIGEST

Volume 35, Number 2

# Denso Petrolatum Tape: 90 years Old and Still Going Strong!

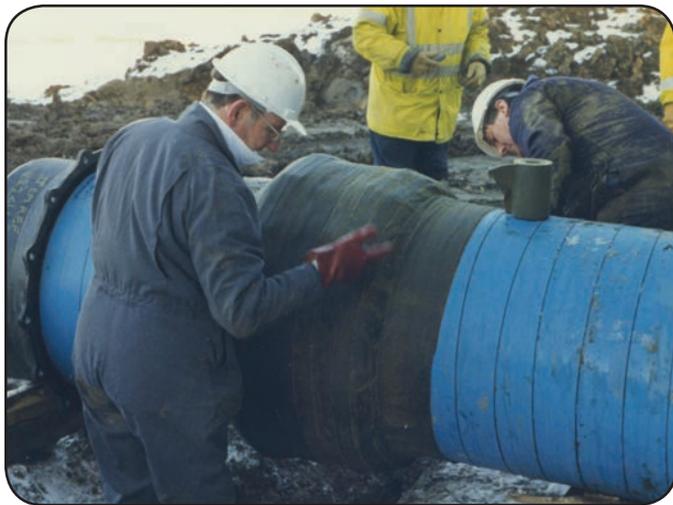
**UK** - Protecting buried Viking Johnson Couplings on water pipework at Whorely Reservoir which supplies Darlington and parts of Teeside.

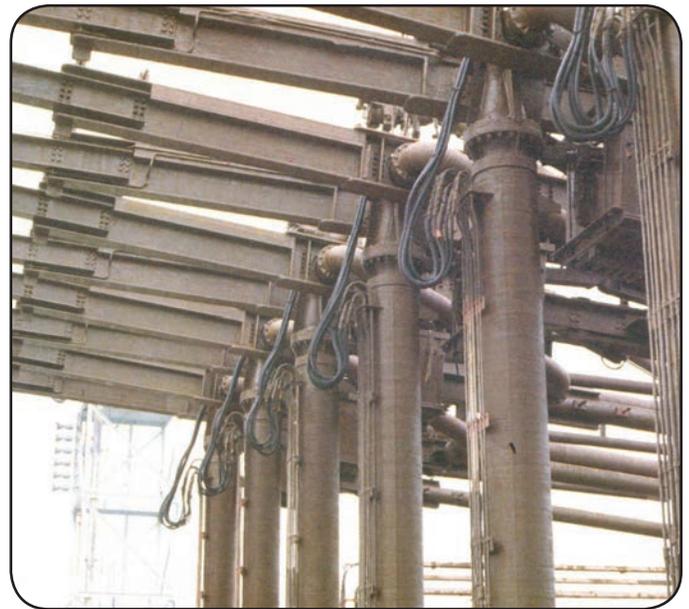
**UK** - Protecting loading booms at the Esso Milford Haven Refinery, using weatherboard and spiral tape wrapping techniques.

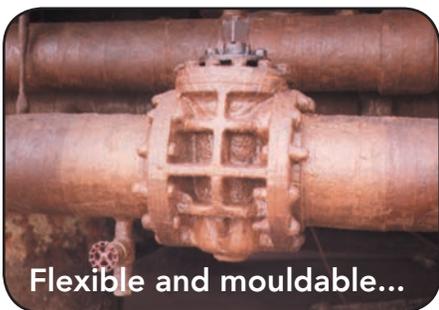
Flexible and mouldable...

1. It is very easy to apply.
2. It is extremely flexible, mouldable and it can be overpainted to create a tough outer armouring.
3. It is surface tolerant and can even be applied over thin layers of tightly adhering rust.
4. It is self-adhesive and adheres to most building materials.
5. It is easily removed to check the condition of the substrate and easily repaired again afterward.
6. Cost effective, once applied in the recommended way it will continue to work and protect for decades.

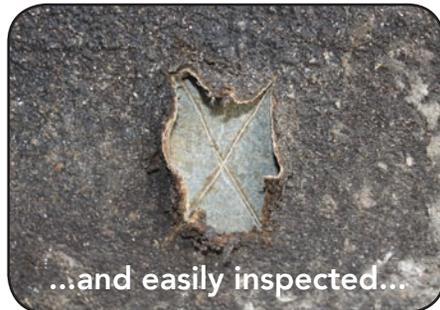
...and easily inspected...

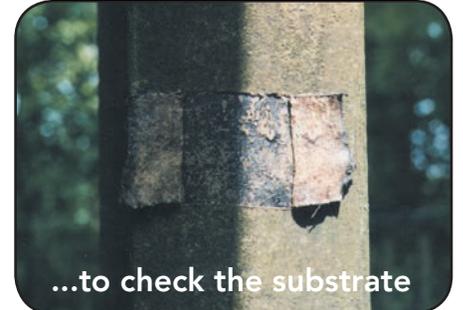
...to check the substrate

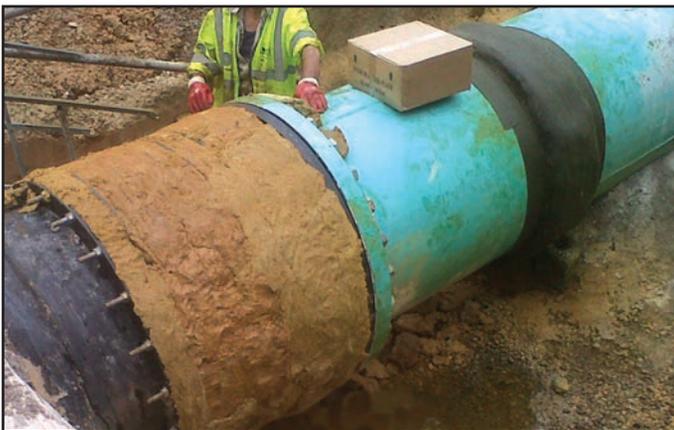
Denso Profiling Mastic™ is used to create a smooth profile prior to tape wrapping.

The Denso™ Petrolatum Tape System was chosen to protect the bolted flanges on the new water main. The system which is applied after cleaning comprises an application of Denso Paste™ followed by Denso Profiling Mastic™ to fill voids and smooth profiles. To complete the system, a spiral wrap of Denso™ Petrolatum Tape using a 55% overlap is applied to give a double layer of protection.

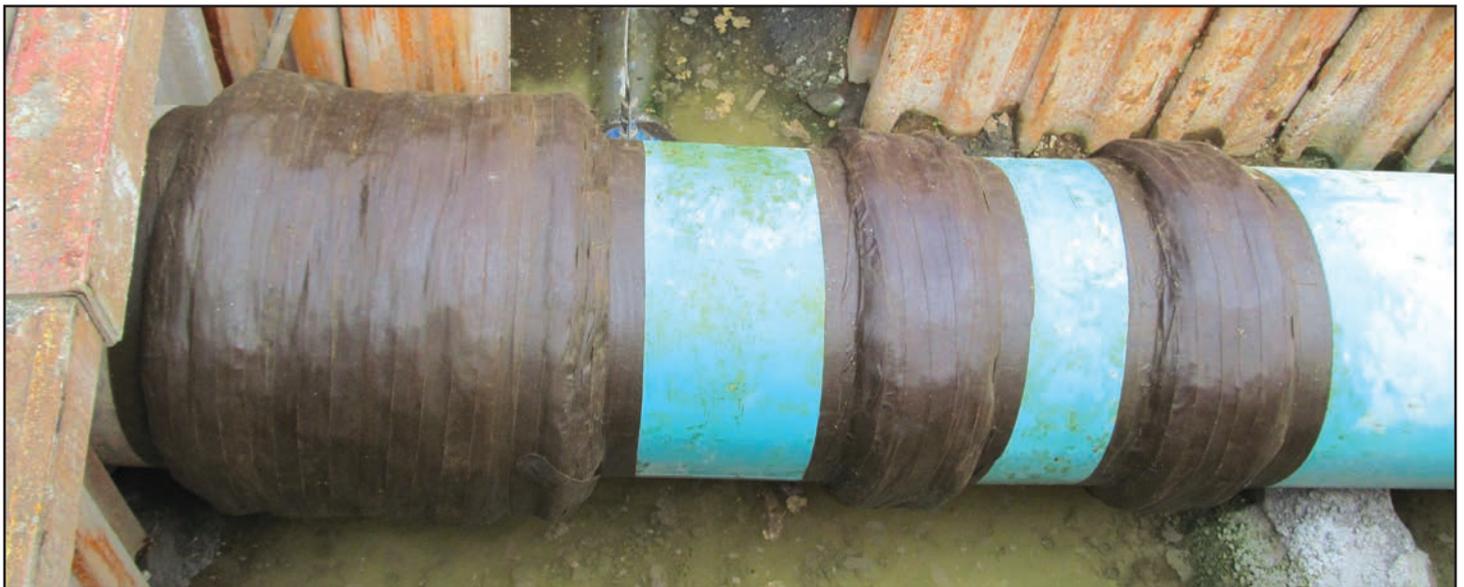
The completed Denso™ Petrolatum Tape System protecting the pipe joints.

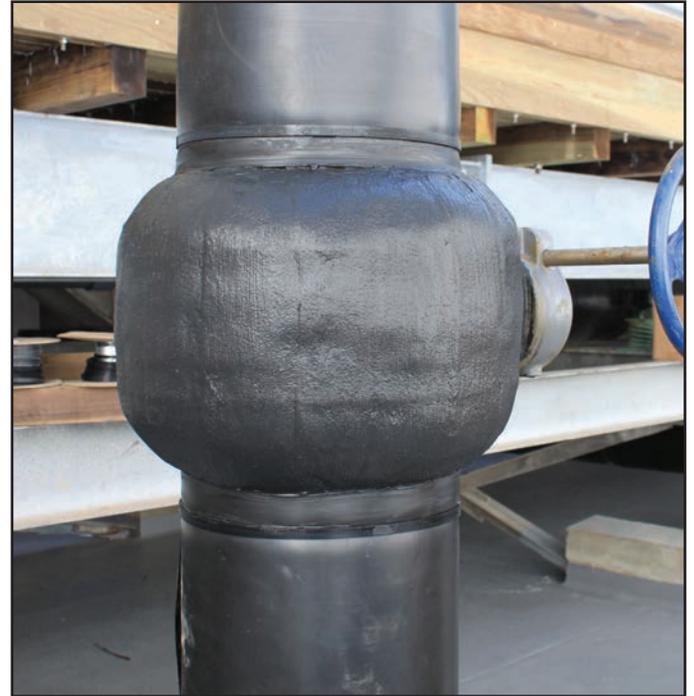
Archco 15™ Acrylic Topcoat is brush applied onto Densyl™ Tape protecting a valve flange as a top coat.

For irregular areas such as flanges and valves, Denso Profiling Mastic™ was also applied to provide a smooth profile to tape over and then top coated with the Archco 15™ Acrylic Topcoat in place of the Denso HDPE Outerwrap™.

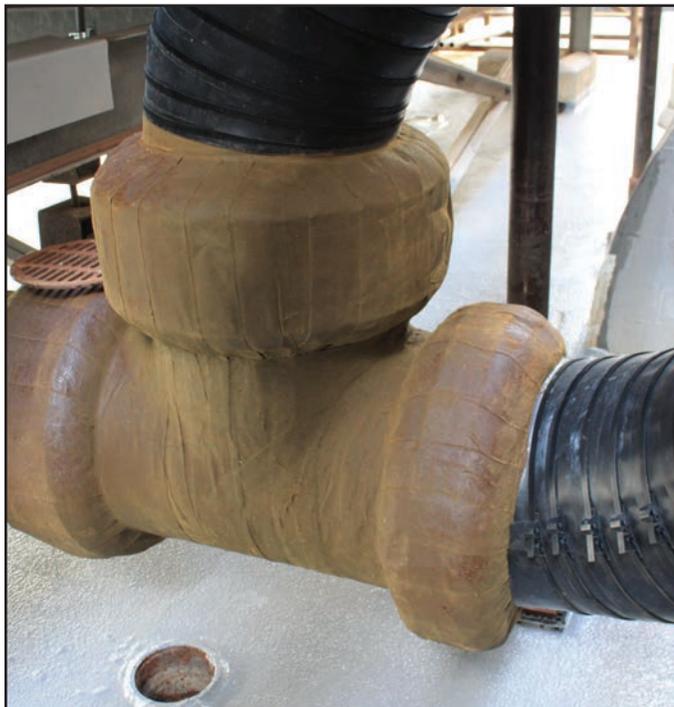
A large pipe tee joint wrapped with Densyl™ Tape prior to the application of Archco 15™ Acrylic Topcoat. The Denso HDPE Outerwrap™ is shown on the connected pipes.

After a short on-site training session with a Denso representative, the contractor MFR Fluid & Air was able to install the Denso™ Petrolatum Tape system quickly and easily much to their satisfaction. The scope of work consisted of minimal surface preparation (SSPC SP-2/SSPC SP-3), followed by the application of a thin layer of Denso Paste S105™, Densyl™ Tape with a 55% overlap, and a protective layer of Denso HDPE Outerwrap™.

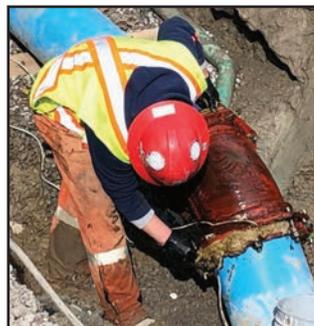
*Applying Denso Profiling Mastic™ to the pipe joints prior to wrapping with Denso LT™ Tape.*

As part of the strategy for prolonging the life of the buried metallic components of their waterworks system, First Nations Engineering Services specified the use of Denso Paste™, Denso Profiling Mastic™ and Densyl LT™ Petrolatum Tape.

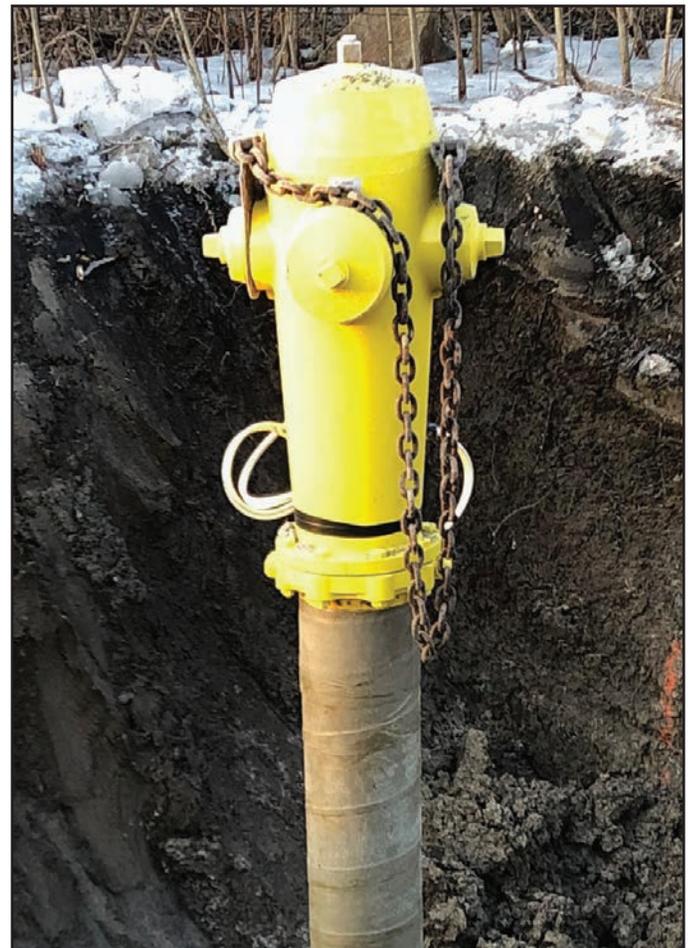
Water hydrant supply pipework protected with the Denso LT™ Petrolatum System.

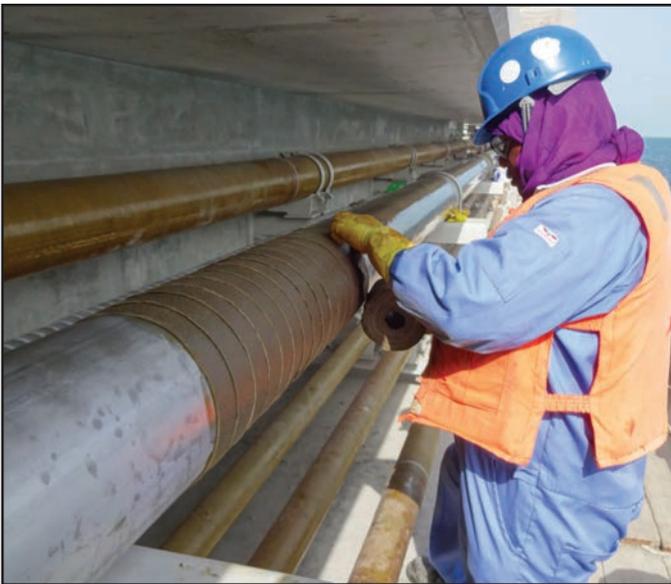
First a coat of Denso Paste™ is followed by a spiral wrap of Densyl™ Petrolatum Tape.

Due to these harsh conditions the project consultant decided that the best solution for the long-term protection of the pipes was a modified Denso Steelcoat™ System. The modified system comprises a coat of Denso Paste™ overwrapped with Densyl™ Tape using a 55% overlap. This was then followed with a wrap of Denso Ultraseal RT™ Tape using a 55% overlap which was then coated with two coats of white Denso Acrylic Topcoat™.

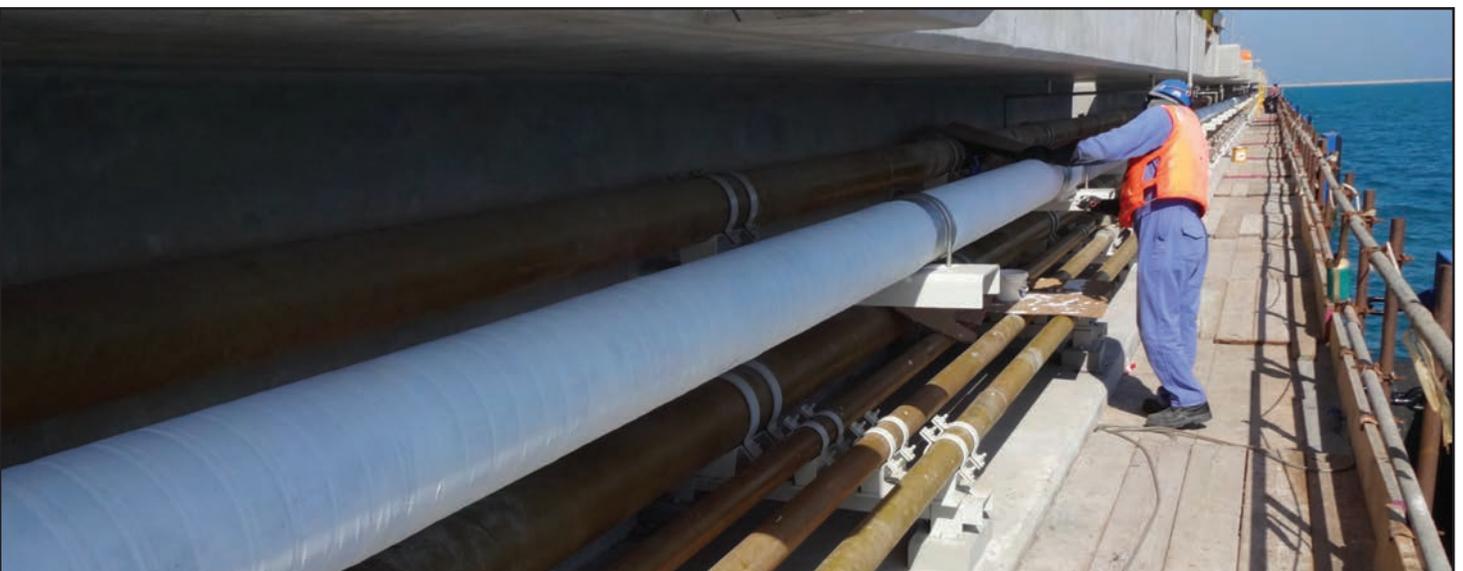
After applying a spiral wrap of Denso Ultraseal RT™ Tape, two coats of Denso Acrylic Topcoat™ completes the pipe protection system.

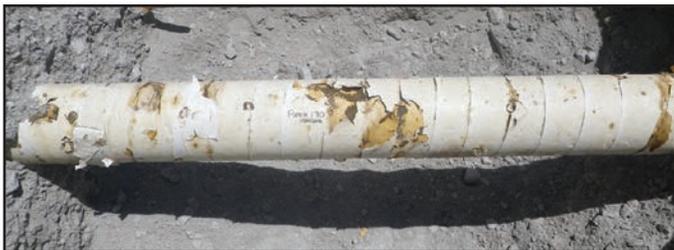
The original Denso™ system had probably been damaged by backfill.

All three excavations found the Denso™ Outerwrap to be slightly damaged which was presumably caused by the backfilling of the trench. No damage was noticed on the Denso™ Petrolatum Tape inner wrap which was still found to be saturated with the petrolatum compound.

The entire coating system was removed and the pipe surface was cleaned. No corrosion whatsoever was evident after 30+ years since it’s installation in 1988.

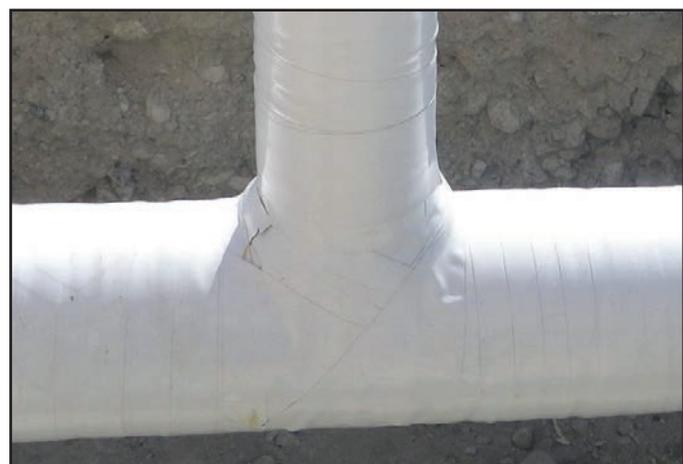
The new tie-in protected with the the Denso™ Petrolatum Tape System.

Recently a 6” tie-in was installed and wrapped for a new fire water system installation at the Main Store using the original system supplied back in 1988!

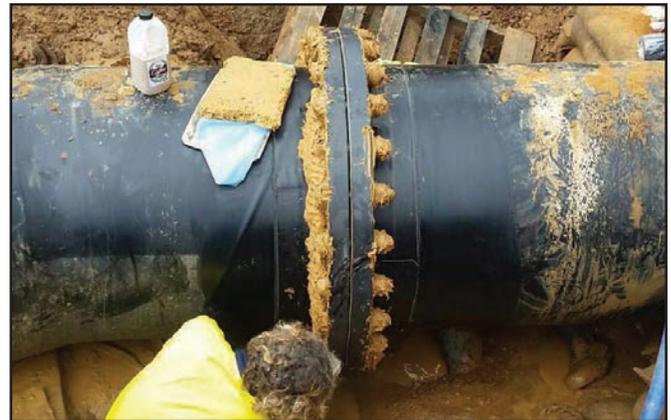
Below: Denso Profiling Mastic™ is used to create a smooth profile for wrapping.

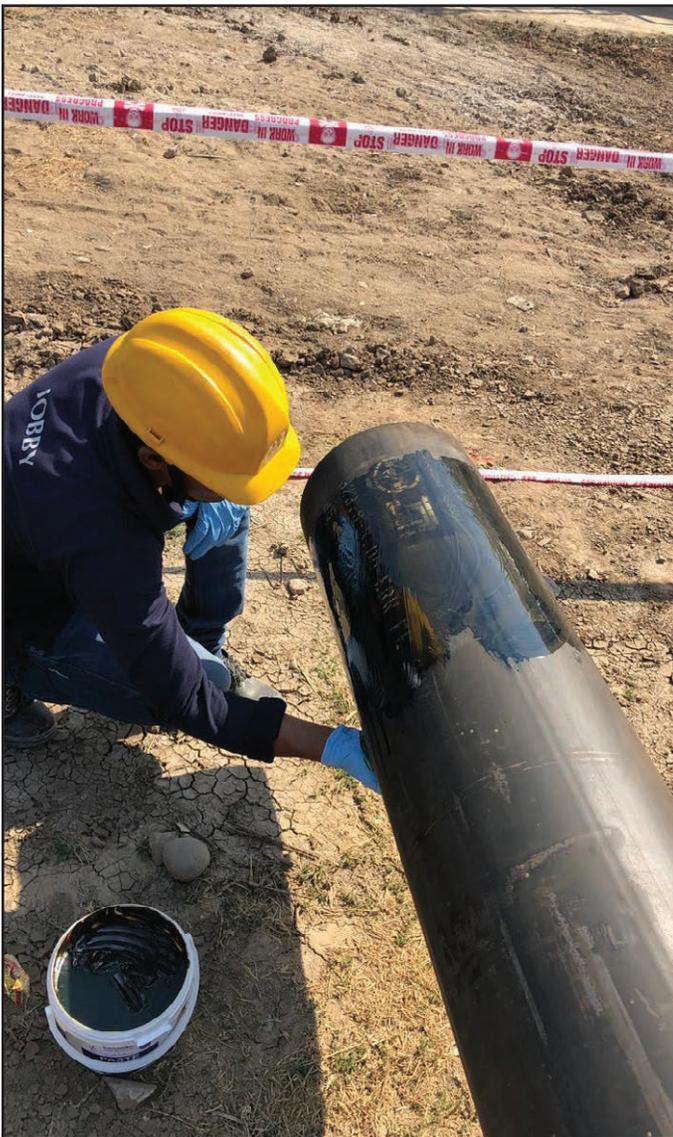
Denso Paste™ is applied to the cleaned pipe surface.

A consultation with the site head and engineering team was organised, where a demo installation was provided along with an overview of our products and services. Once the client could see how easy it was to apply the system, which consisted of Denso Paste™, Densyl™ Tape and Densopol 60HT™ Tape, it was approved for all pipes.

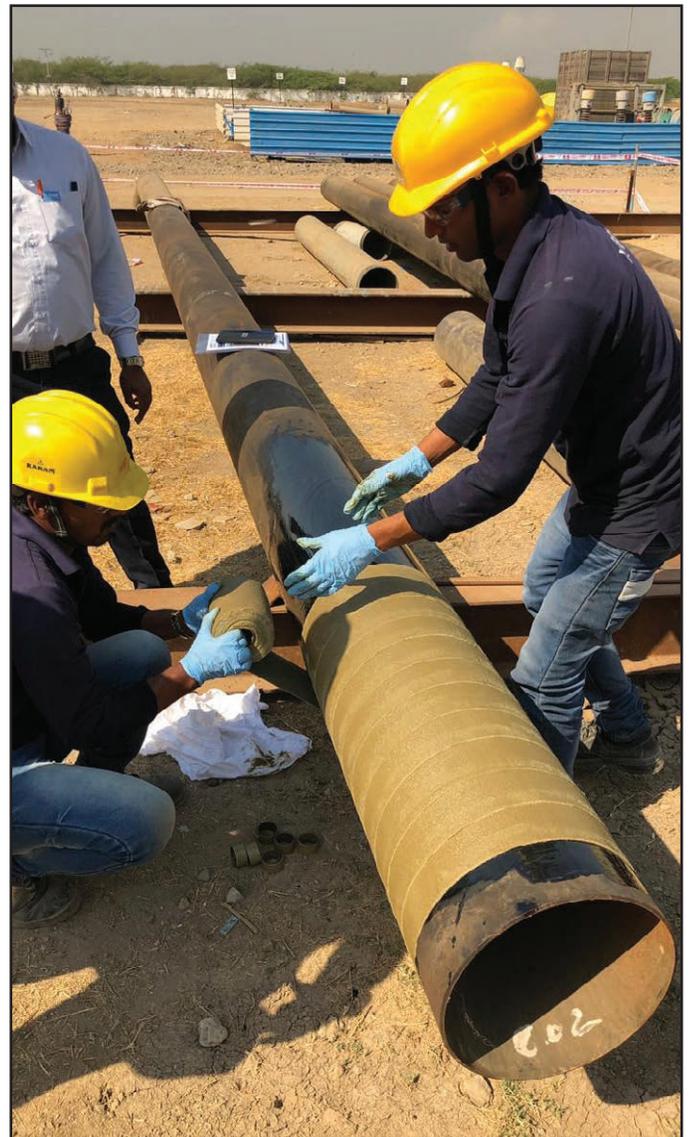
Densyl™ Petrolatum Tape is circumferentially applied over the Denso Paste™.

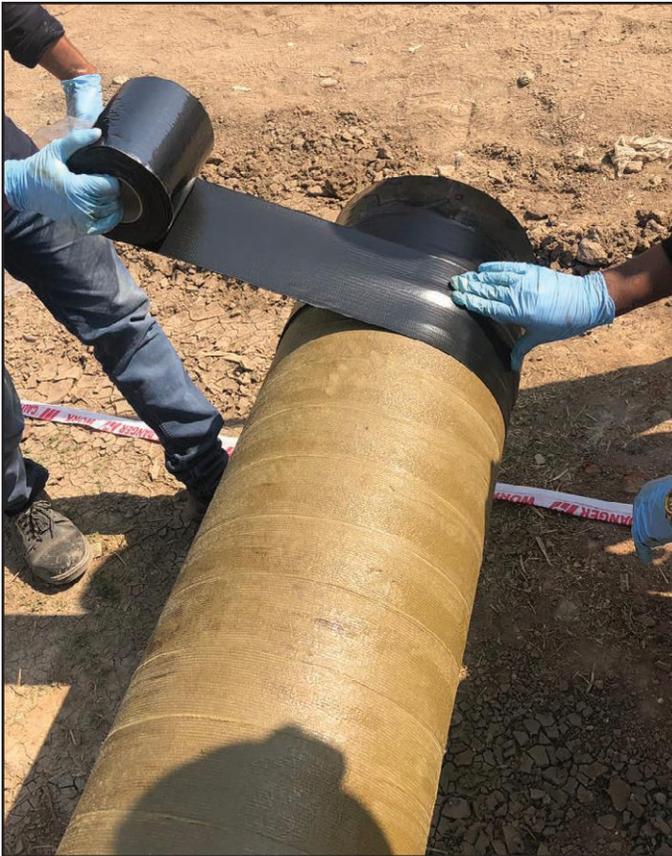
A wrap of Densopol 60HT™ Tape is applied to complete the system.

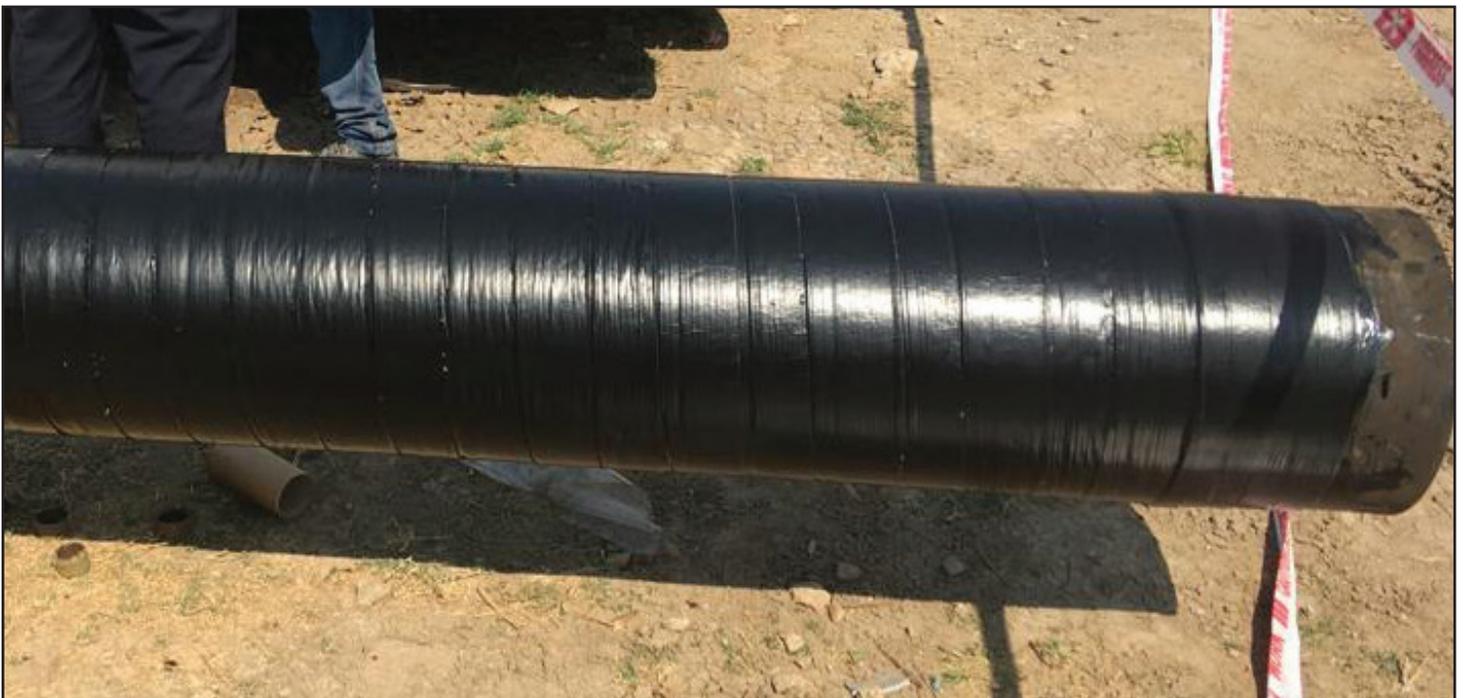
A completed section of pipe.
