Winn & Coales International Ltd.

# DENSO DIGEST

Volume 37, Number 1

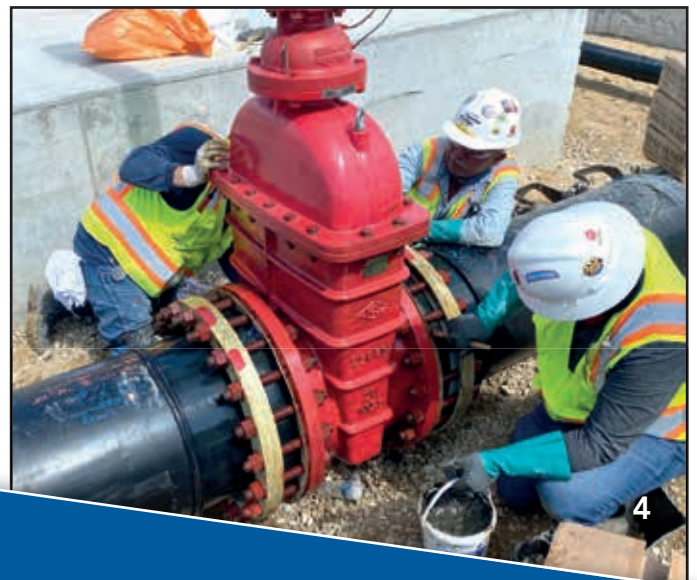
*Denso Paste is easily applied to the substrate by gloved hand or brush as the initial application step.*

The Petrolatum Tape System is comprised of 3 main components and typically has an outerwrap for mechanical protection. This application uses Denso™ Paste, Denso™ Profiling Mastic, Densyl™ Tape, and Denso™ Glass Outerwrap for mechanical protection. This system is easily applied by hand without requiring specialized training or equipment. Furthermore, the application can commence with minimal surface preparation of SSPC-SP 1/2. First, the Denso Paste is applied as the first defense layer of corrosion prevention. This petrolatum primer helps fill in any pitted areas where the Densyl Tape may not come into contact with the surface and contains moisture-displacing corrosion-inhibiting compounds. The second step is application of Denso Profiling Mastic on the flanges and valve's irregular and sharp corners, to create a smooth profile across these areas before applying the Densyl Tape. The Densyl Tape, a petrolatum wax tape, is then spirally wrapped by hand over each flange and valve to completely seal out oxygen and water.

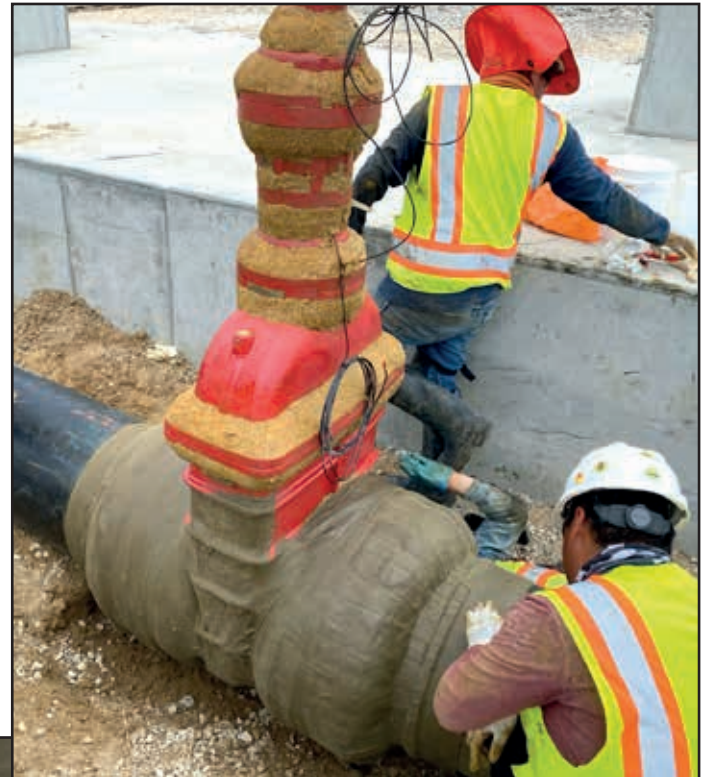
*Opposite: A smooth profile is achieved with Denso Profiling Mastic prior to the application of Densyl Tape.*

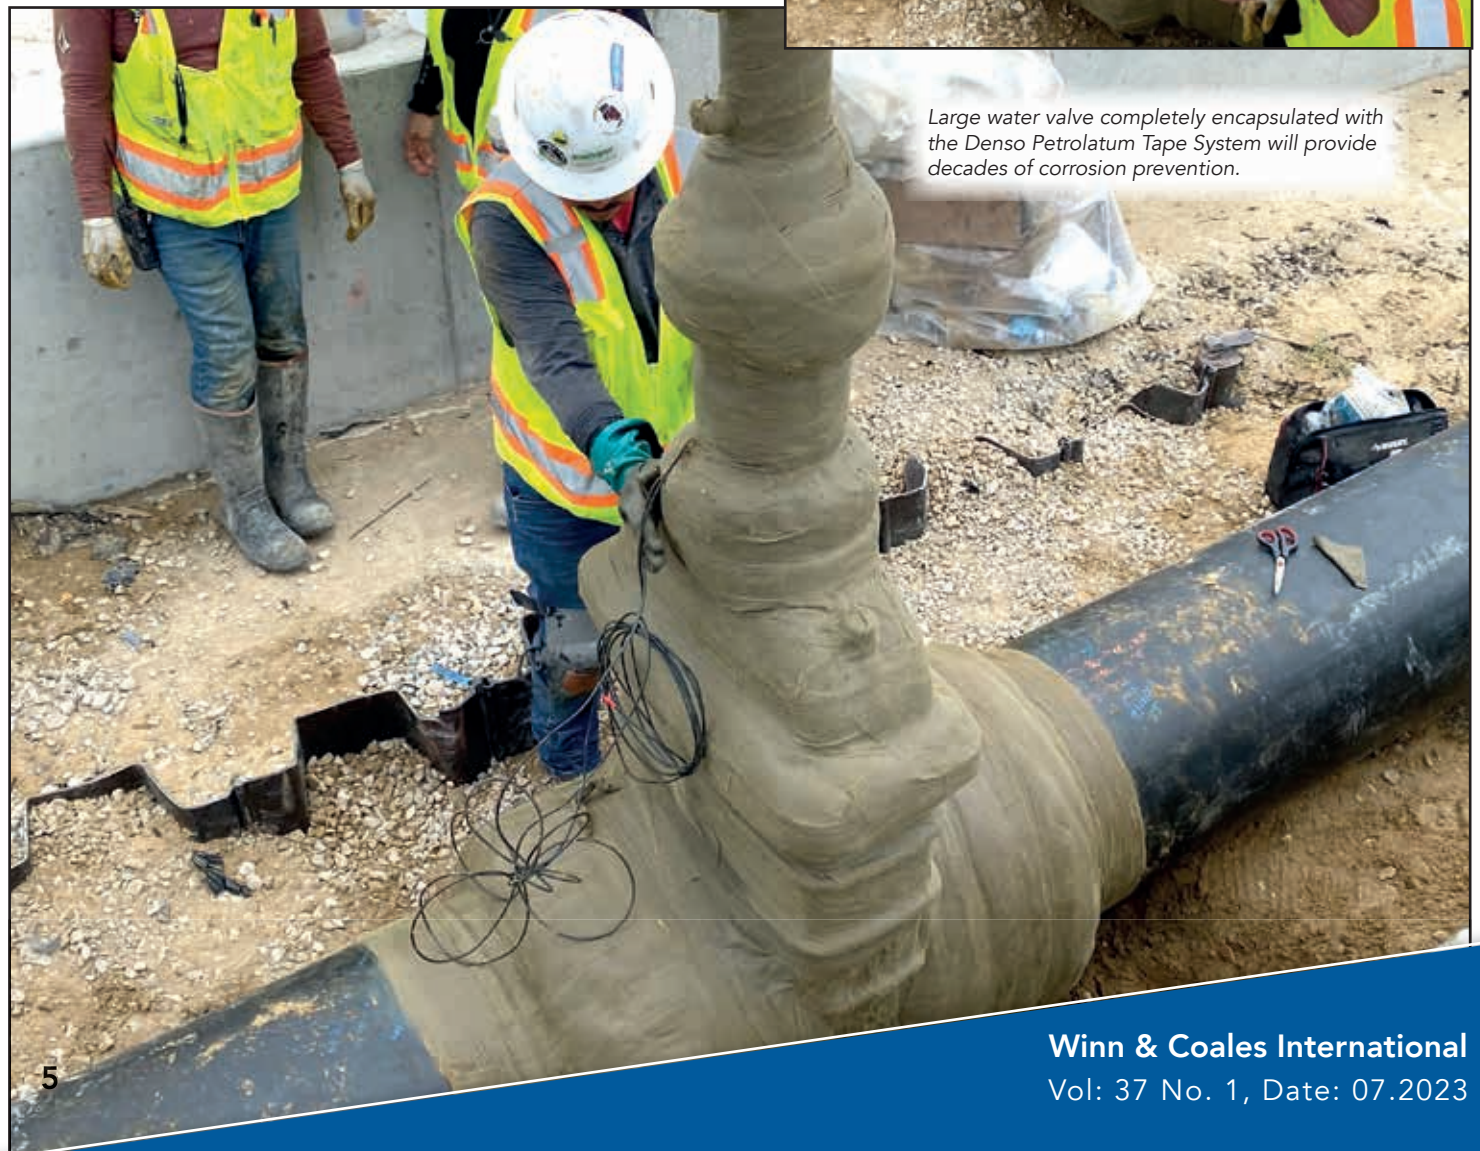
*Large water valve completely encapsulated with the Denso Petrolatum Tape System will provide decades of corrosion prevention.*

Depending on the project's environment and during backfill, there are several different Denso options for an outerwrap to protect the Denso system and keep it in place. In this instance, Denso™ Glass Outerwrap was used as the outerwrap. This material cures quickly, within 30 minutes, creating a hard protective shell around the tape system underneath from mechanical damage. Once cured, the tape system is ready to be backfilled. The Denso™ Petrolatum Tape System meets NACE RP0375-2006 and AWWA C217 standards and is also CSA Z245.30 compliant.

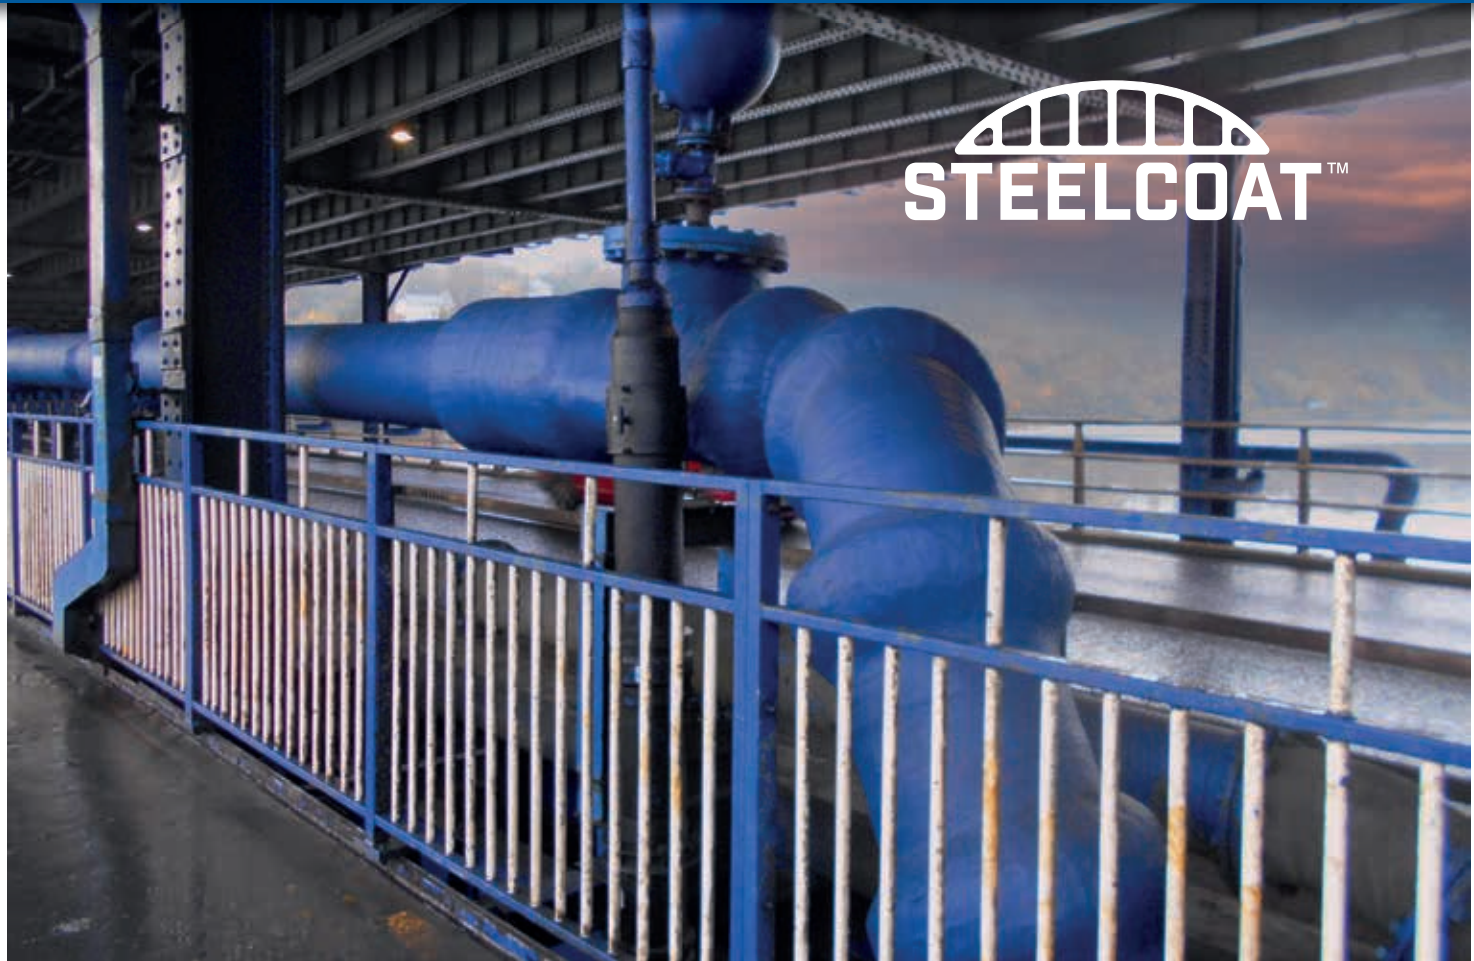
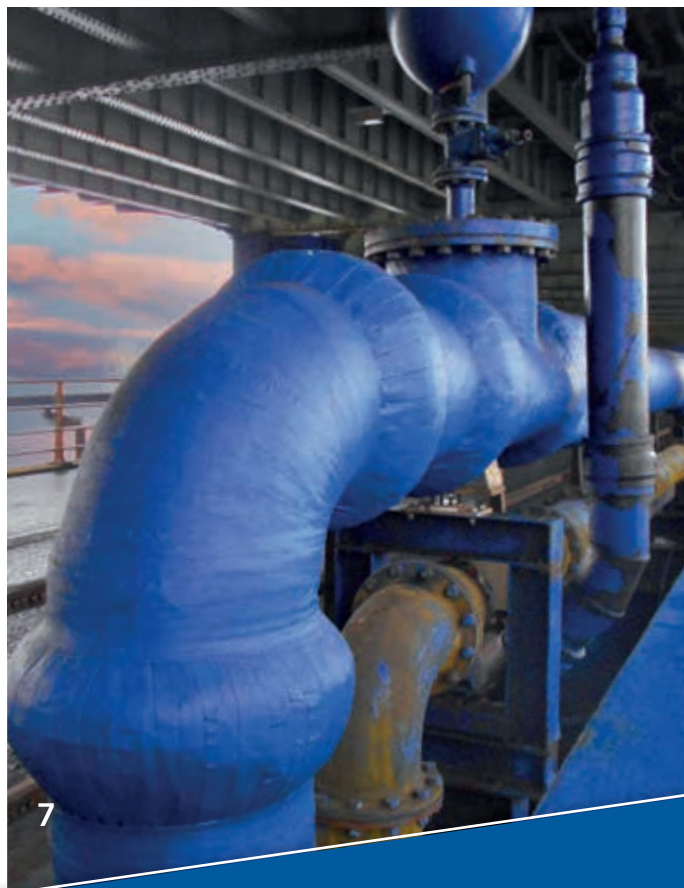
Above and below: The Denso™ Acrylic Topcoat that completes the Steelcoat 100/400 System protected waste water pumping main, was coloured blue to match the surrounding steelwork.

The System consists of Denso™ Hi-Tack Primer, Denso™ Profiling Mastic, Denso™ Hi-Tack Tape, Denso™ Ultraseal Tape and Denso™ Acrylic Topcoat. On the Craigavon Bridge Contract the Denso Acrylic Topcoat was supplied in same blue colour as the bridge structure.

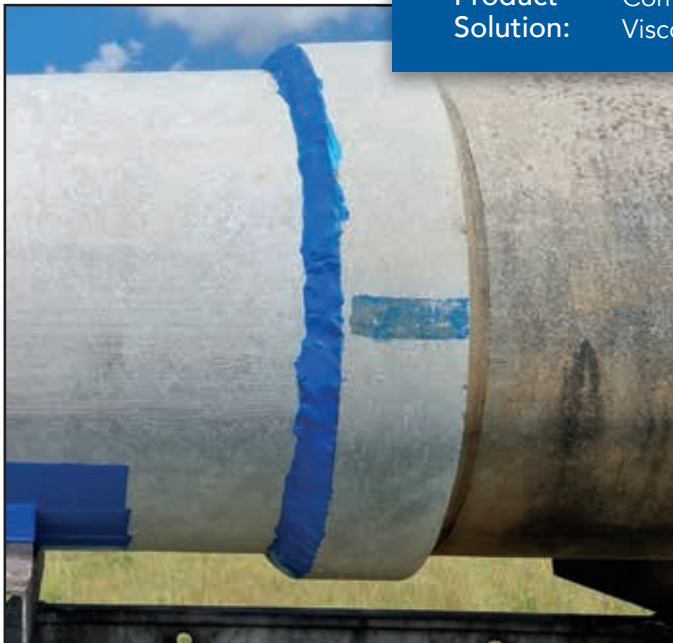
Above: Denso™ Glass Outerwrap coated with Denso™ Shield applied as the final mechanical layer.

The surface was suitably prepared using a steel wire brush to clean and provide a sound surface for the coating to adhere to. Denso proposed Viscowrap™ ST, Denso™ Glass Outerwrap with Denso™ Shield topcoat as the final layer.

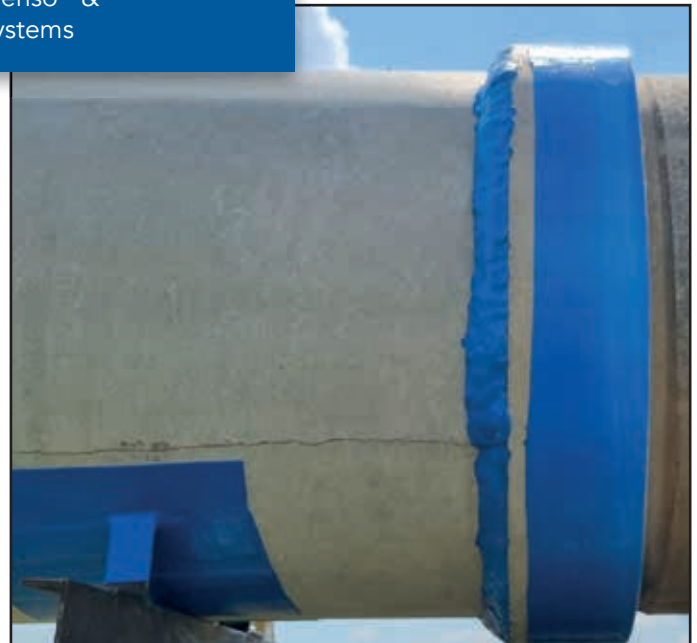
Below: Viscowrap™ ST applied with Viscomastic™ on concrete collar joint.

Viscomastic™ was applied at the spigot and socket interface to provide a uniform surface for both the tapes to conform to.

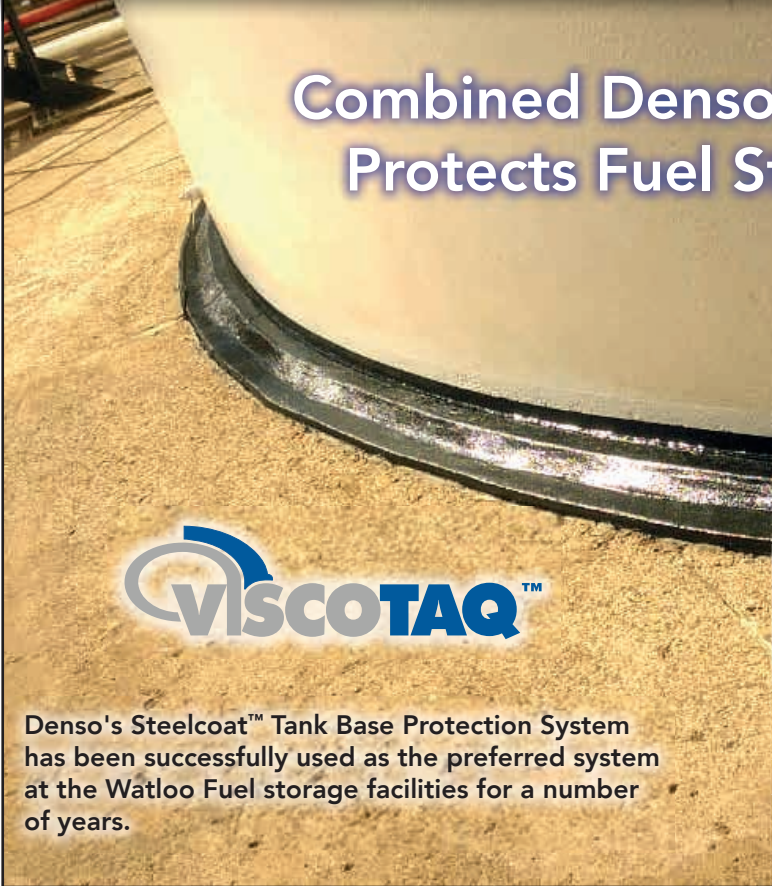
Denso's Steelcoat™ Tank Base Protection System has been successfully used as the preferred system at the Watloo Fuel storage facilities for a number of years.

Engineers at the fuel storage plant decided that they would prefer to have the weld between the tank body and the ring beam exposed at all times and would therefore only require a "water-tight seal" between the concrete plinth and the steel ring beam to seal off any possible ingress of water or fuel spillages that may result in the corroding of the tank base.

After the applied demonstrated section was exposed to the elements and harsh conditions for two months, the plant engineers approved the system to wrap the first tank with a circumference of 40m.

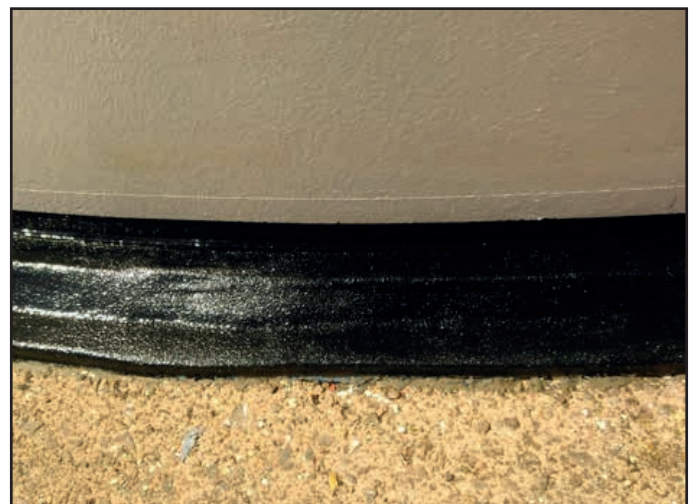
*Applied Viscotaq™ EZ Wrapping with Denso™ Shield Topcoat.*

The combined system used consists of Denso Butyl P16HT™ Primer, Viscomastic™, Viscowrap™ EZ Wrap, Denso™ Basecoat and Denso™ Shield Topcoat.

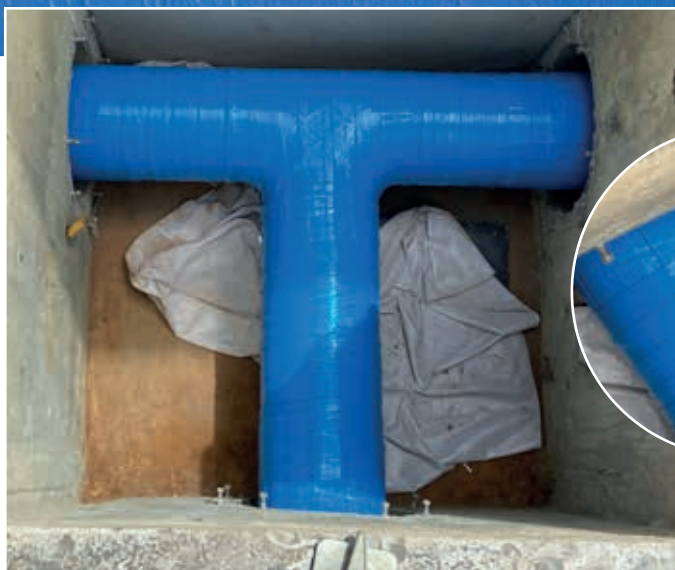
Picture: Viscowrap™ HT applied to the fuel pipeline.

Auckland Airport chose the Viscotaq™ tape coating material which can be applied efficiently in the field with minimal preparation and yet provides excellent long term corrosion protection. Viscowrap™ HT was selected as the preferred coating solution due to minimal surface preparation requirements, remains flexible, no VOC and ease of application in confined locations around the Airport. It has been applied in multiple locations since 2021.

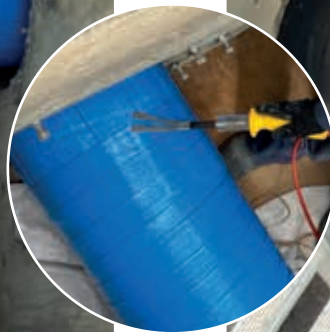
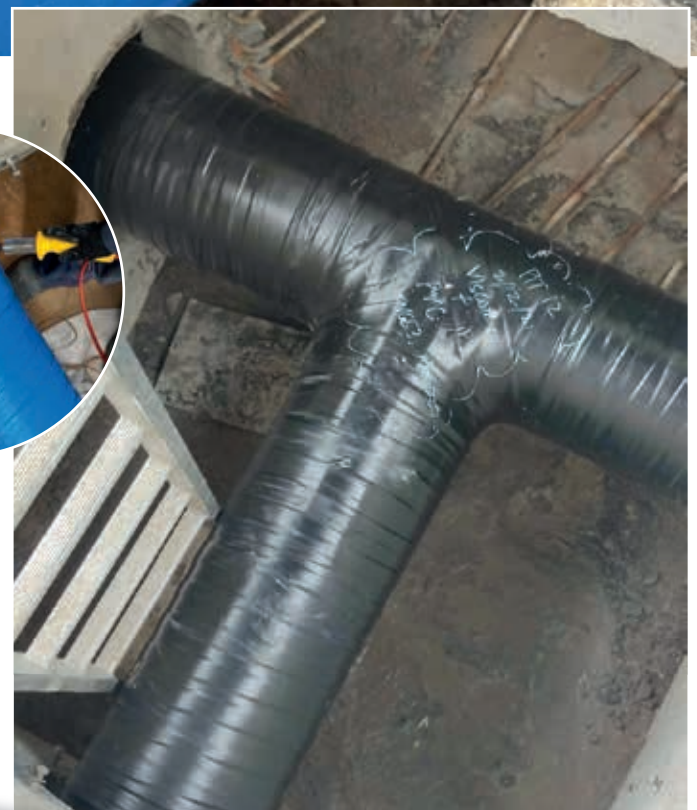
Above: Viscowrap™ HT applied to a tee junction.  
 Centre: The completed Viscotaq coating is checked for holidays.  
 Right: A wrap of black Denso PVC Tape completes the protection.

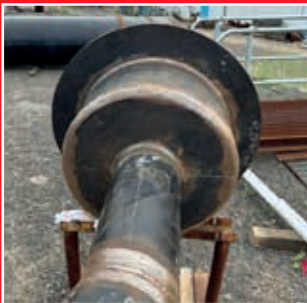
1. Surface preparation

The SUMP Assembly began with careful surface preparation of the steel followed by a field 'peel test' of the ViscoWrap™ ST. This test is completed as a prequalification to confirm whether the surface cleanliness has been prepared to the respective standard. Following this, ViscoMastic™ was applied around the flange area of the SUMP Assembly.

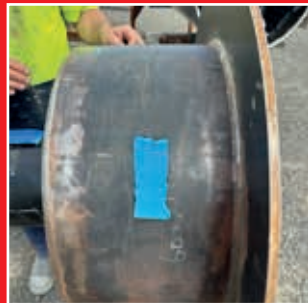
2. Field Viscowrap ST peel test.

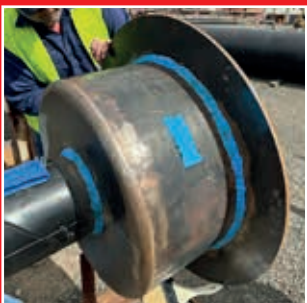
3. ViscoMastic is applied.

The ViscoMastic acts as a contour to allow ViscoWrap ST to be applied without any voids or air pockets at the flange face. ViscoWrap ST coating was used to feather each vertical face. The feathering process used 100mm wide tape which was then tied in on all circumferential regions using ViscoWrap ST 300mm wide tape.

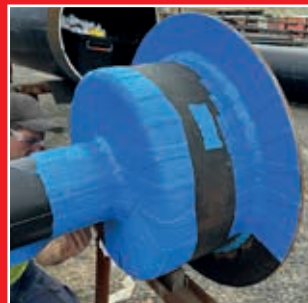
4. Viscowrap ST is applied.

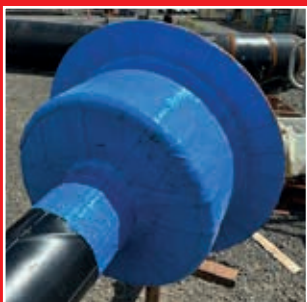
5. Complete Viscowrap ST wrap.

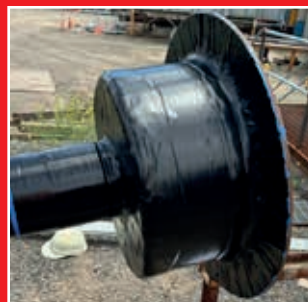
6. Denso PVC Tape overwrap.

As the final step for the SUMP Assembly, Denso™ PVC Tape was applied for below-ground mechanical protection using the same wrapping principles as ViscoWrap ST.

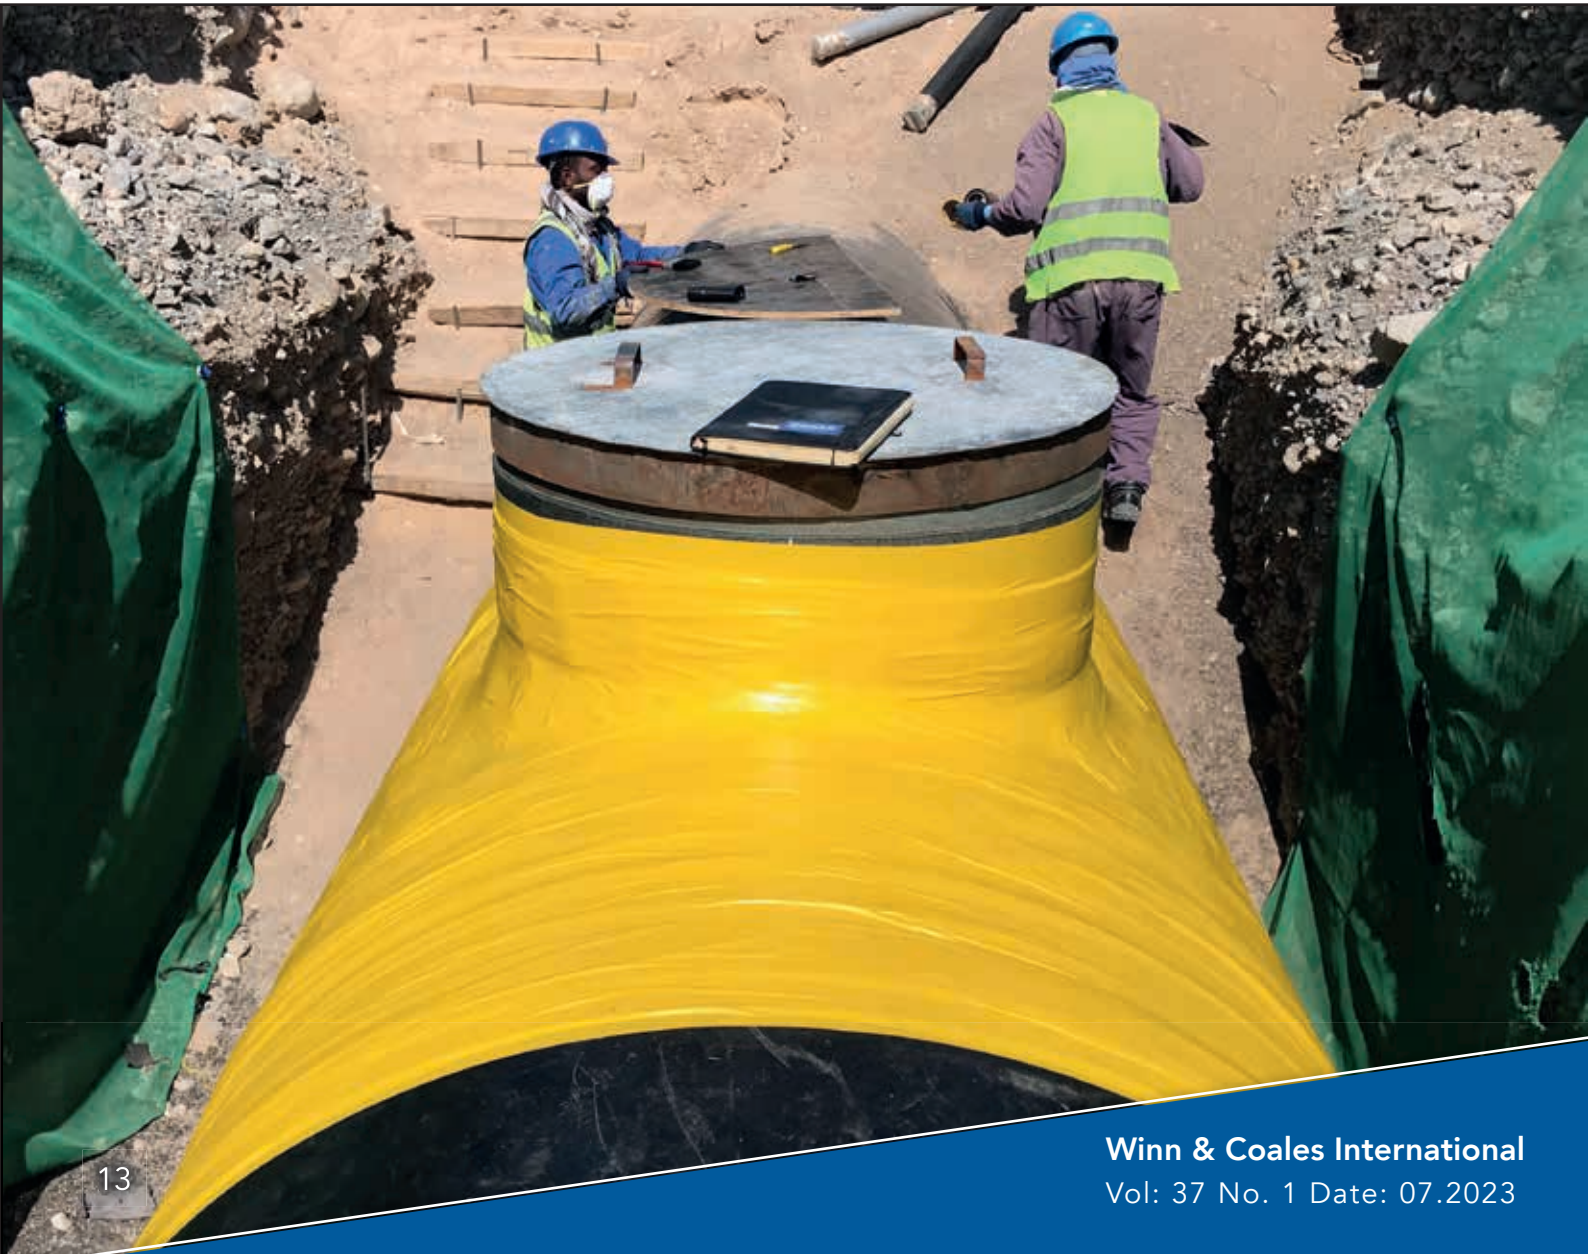
*Below: The Densopol 80HT™ Tape System comprises: Denso Primer D™, Densyl™ Mastic, Densopol 80HT™ Tape applied spirally with a 55% overlap and Denso™ PVC SA Tape 200 yellow (Outerwrap) also applied spiral with a 55% overlap.*

All carbon steel pipeline lengths are protected with a 3LPE system. The heavy duty Densopol System was selected for the protection of some of the girth weld joints and the pipe Tees based on its successful case histories on various projects throughout the GCC Region.

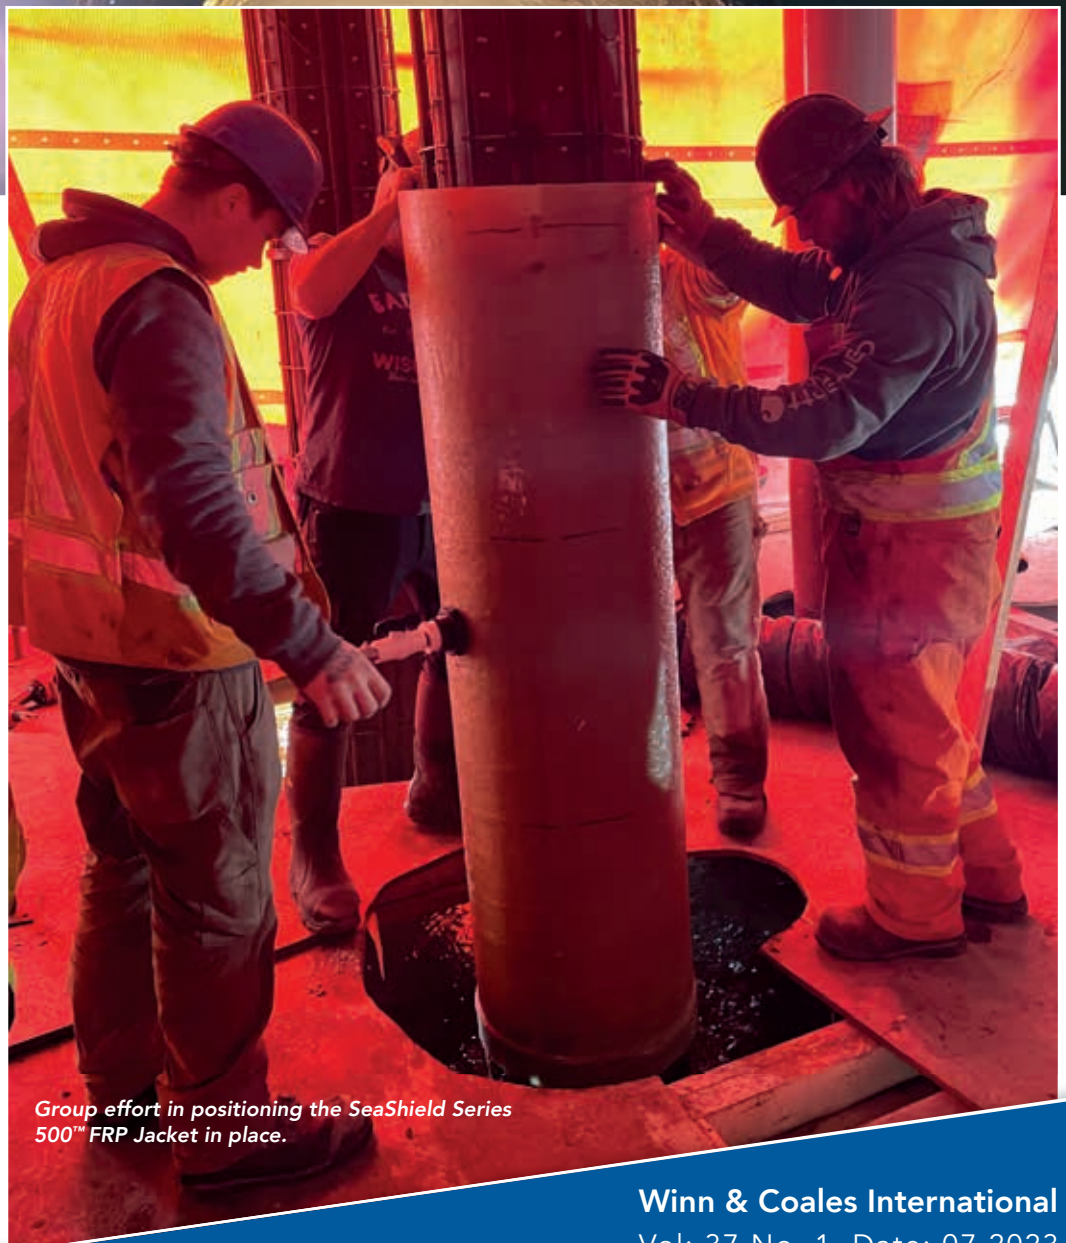
*Group effort in positioning the SeaShield Series 500™ FRP Jacket in place.*

The project used a combination of Series 500 and Series 2000HD Jackets depending on their position. All parties involved worked diligently to successfully carry out the work required.
