Photo depicts side view of piles with mooring hooks and fender brackets after wrapping. See page 12.

DENSO DIGEST

Volume 37, Number 2

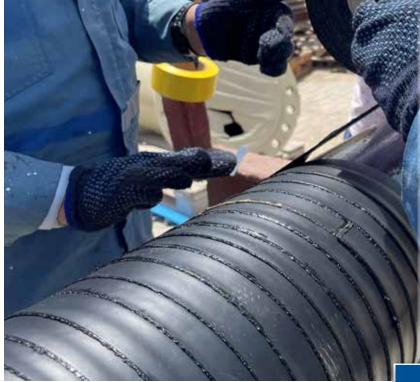
Above: Densopol 80HT™ is applied over Denso Primer D™.

Below: Denso PVC SA Tape[™] is then applied to the pipe lengths over the Densopol 80HT[™] for extra mechanical protection during transportation.

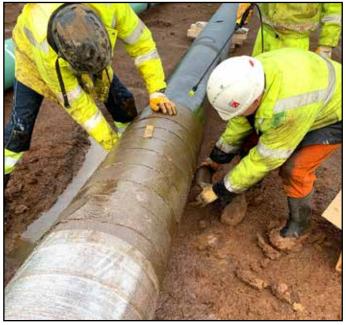
Denso Bore-Wrap[™] is applied spirally with a 55% overlap to the pipe, followed by the application of Denso Polywrap[™] to aid curing of the Bore-Wrap[™].

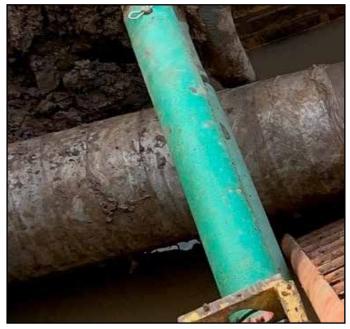
View of pipe after it had been pulled under the roadway. Denso Bore-Wrap™ is still intact so there is no damage to the pipe coating.

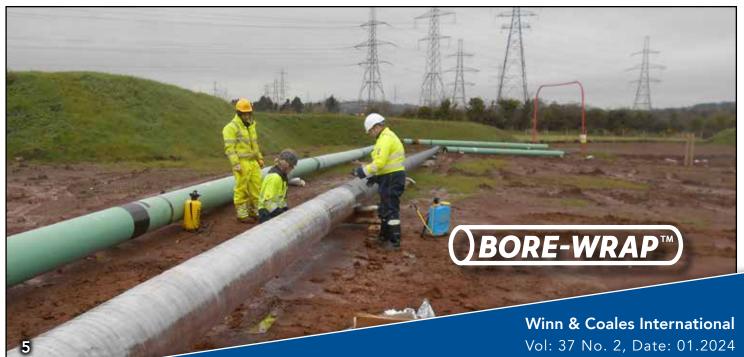
The Denso Bore-Wrap[™] is applied to the pipe then sprayed with water triggering the curing process that turns it into the abrasion resistant outerwrap.

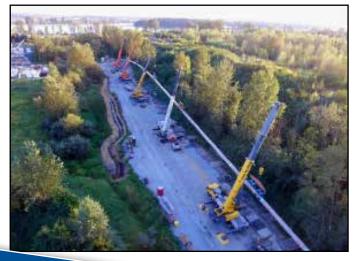
Denso Bore-Wrap[™] is applied to the wastewater pipeline to protect against abrasion, during the pull back carried out in a directional drilling operation under the Fraser River.

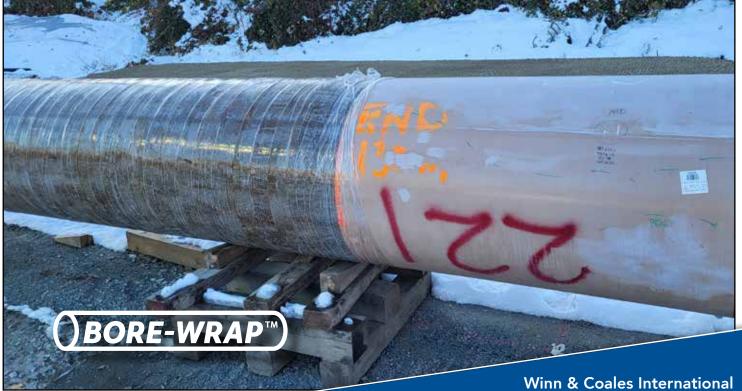
Denso Bore-Wrap[™] application to wastewater pipeline

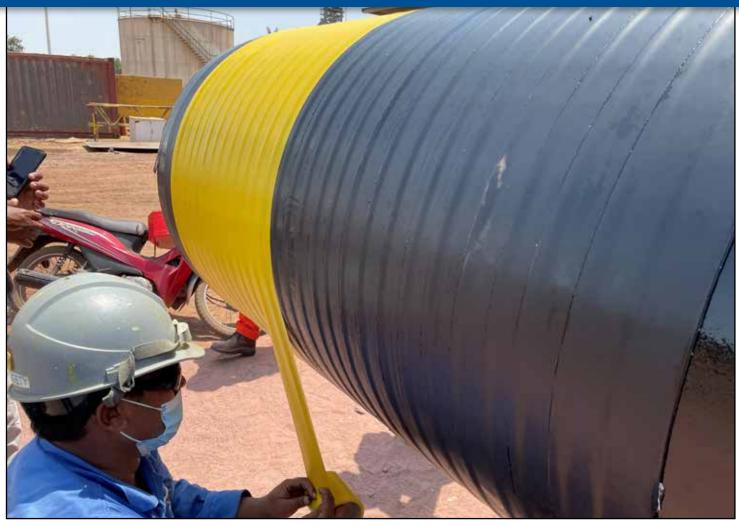
Densopol 80HT[™] is applied over a coat of Denso Primer D[™].

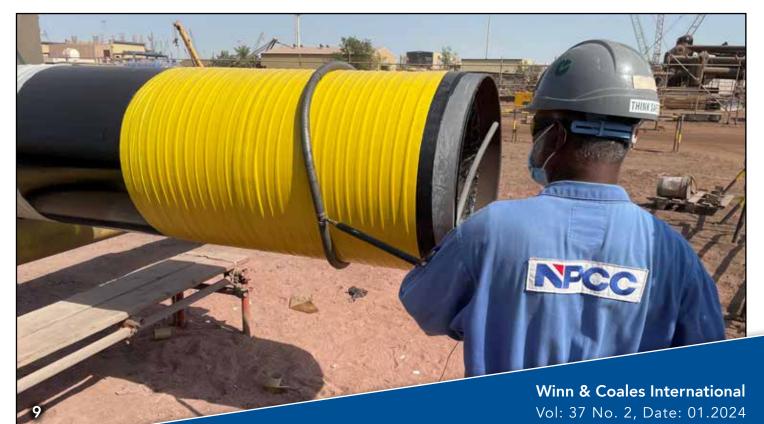
Denso PVC SA Tape[™] is applied to the pipe lengths over the Densopol 80HT[™], to give extra mechanical protection during transportation to the jobsite.

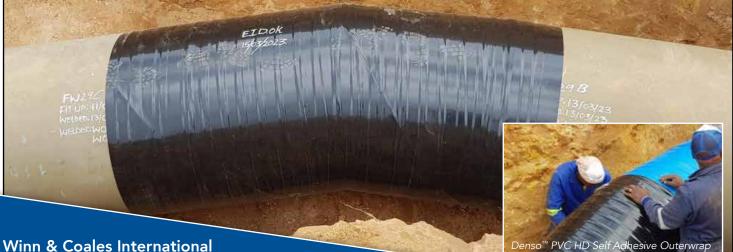
Above: Thorough holiday testing of the Viscowrap[™] ST coating is carried out before the Denso[™] PVC HD is applied.

Below: Denso[™] PVC HD applied at 55% overlap over the Viscowrap[™] ST to offer mechanical strength and sufficient squeeze on the applied innerwrap.

Contractors applying Viscowrap[™] ST on the prepared field joint, overlapping onto the shop applied PU coating.

enso[™] PVC HD Self Adhesive Outerwrap being applied over the innerwrap. 10

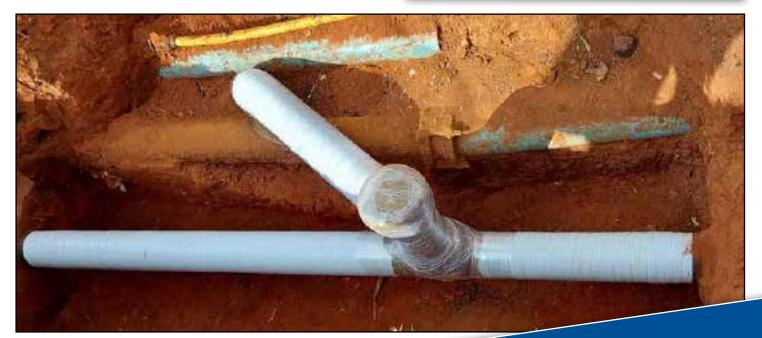
Below: The completed Denso Butyl Tape System now protecting the gas pipeline.

Denso[™] Profiling Mastic and Denso[™] Butyl Tape System applied to the prepared areas.

The surface condition once the existing shop applied coating was removed.

Denso Butyl P16HT[™] Primer being applied in-situ by brush.

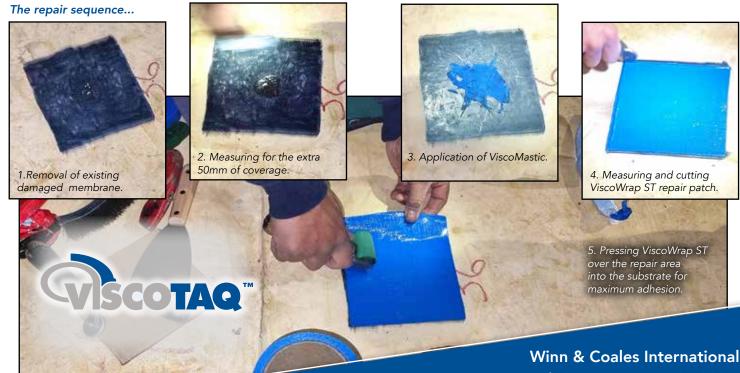
Surface preparation for this project required the use of a grinder to remove the existing membrane off the floor to expose the steel underneath - this was necessary to ensure maximum adhesion of the ViscoWrap[™] ST coating later in the application process.

Next, ViscoMastic[™] was used to cover the damaged area of the floor to assist with filling any pits in the exposed steel.

Following this, the ViscoWrap ST was measured and cut to size with special care being taken to ensure that the dimensions of the cut-out had accounted for at least an additional 50mm of coverage on all sides of the damaged area.

Finally, the ViscoWrap ST was laid over the applied ViscoMastic and firmly pressed down with a siliconised roller.

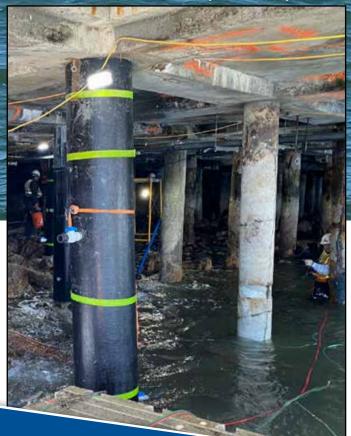
Below: The installation of the SeaShield[™] systems underway.

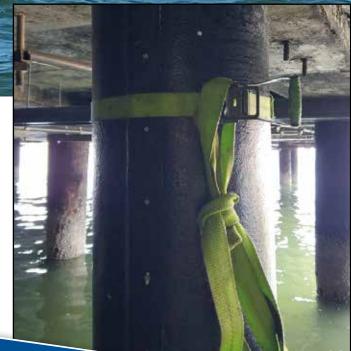
Below: Tensionable strapping is used to hold the SeaShield[™] jackets in place during injection of the epoxy grout.

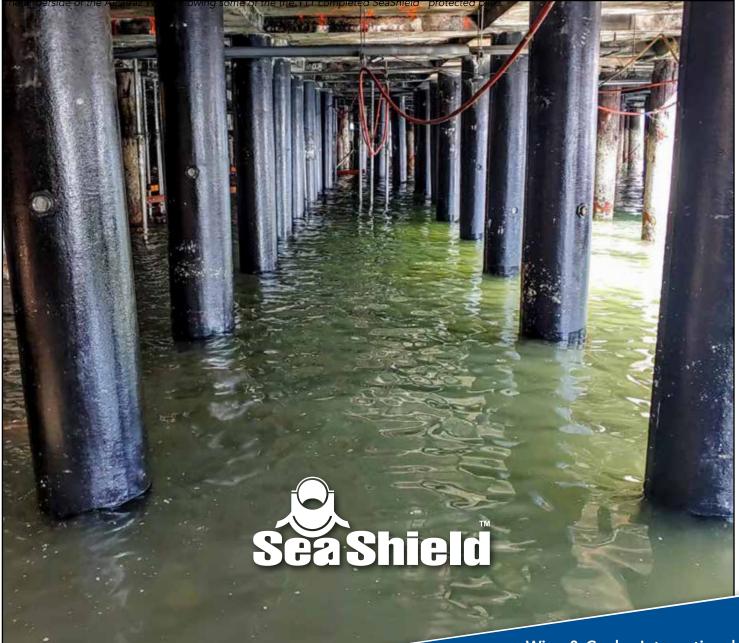
The SeaShield Series FX-70 was used on piles that were deemed no longer structurally sound. The components of the FX-70 System (SeaShield Fiber-Form[™] Jacket, SeaShield FX-225[™] Cementitious Grout, and SeaShield 550 Epoxy Grout) were used in conjunction with rebar to provide a full structural repair to these piles. All SeaShield Fiber-Form Jackets on this project were manufactured with a black finish to minimize visibility.

Denso was asked to provide several SeaShield[™] products to repair 111 piles on the Alcatraz Wharf Repair Project. Both the General Contractor and the Dive Contractor elected to work with Denso as they had successfully installed several SeaShield Systems on numerous projects in the past and were very pleased with the performance and ease of installation.

Denso's SeaShield Series 500[™] was used, as well as a version of our Series FX-70[™], in conjunction with a rebar cage. The SeaShield Series 500 was selected for piles that exhibited some sign of slight degradation, but ultimately were deemed structurally sound, to provide a long-term durable system for corrosion prevention. The 550[™] Epoxy Grout, used within the Series 500 system, is an extremely flowable and pumpable high strength epoxy grout that will fill in any small voids and/or cracks that may be present.
